Fractographic ceramic failure analysis using the replica technique

Scherrer, Susanne; Quinn, Janet B.; Quinn, George D.; Wiskott, Anselm

SCHERRER, Susanne et al. Fractographic ceramic failure analysis using the replica technique. In: Dental materials, 2007, vol. 23, n° 11, p. 1397–1404. doi: 10.1016/j.dental.2006.12.002

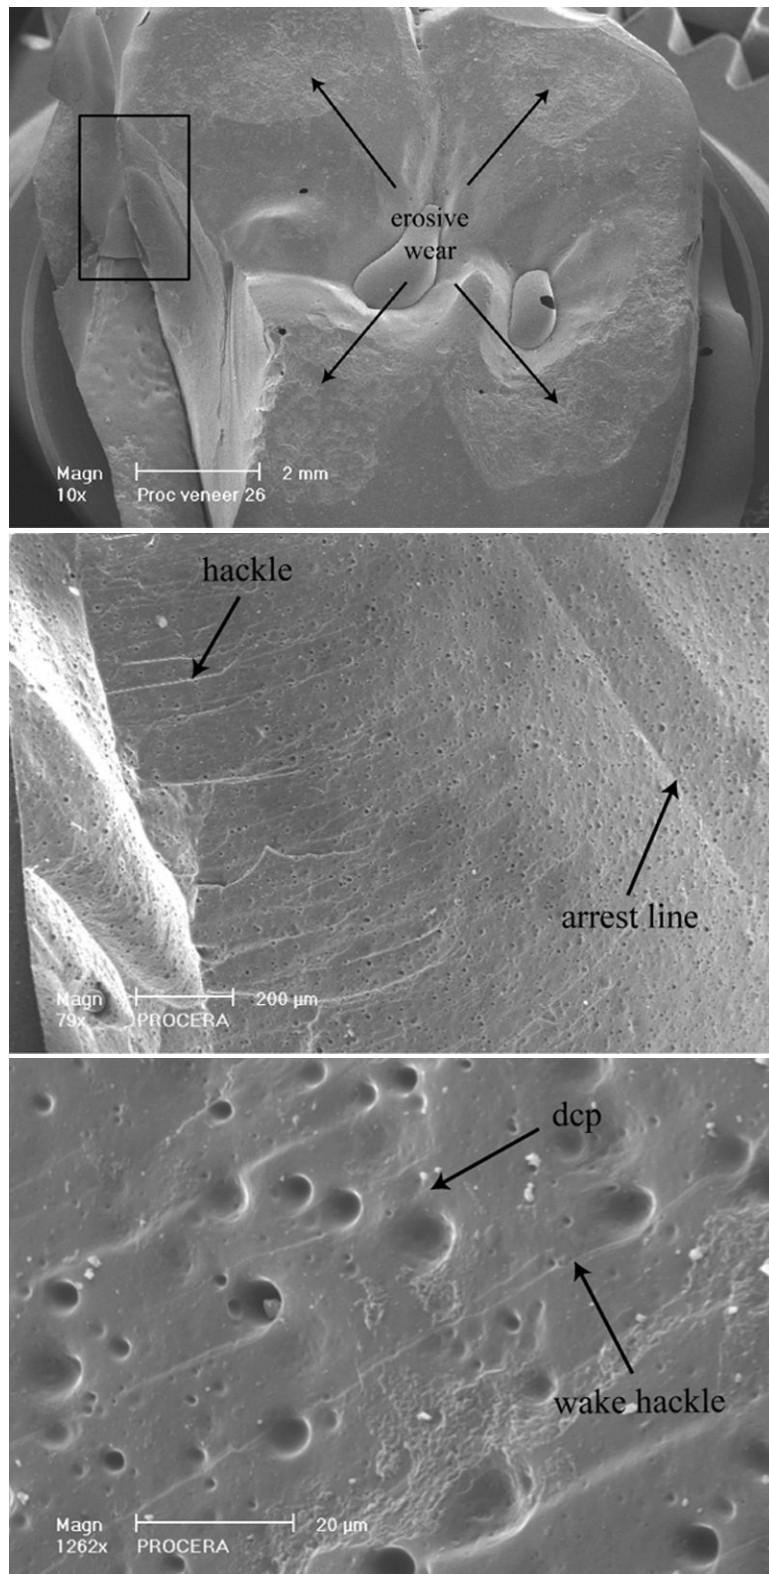
Fig. 5.

The resin replica (Fig.4) of the failed Procera AllCeram crown was sputter-coated with gold and inspected under SEM magnification. Figure 5a shows the crown from an occlusal view at low power (10x). Major erosive wear is apparent on all four cusps, usually a sign of abnormal parafunction habits (bruxism). The zone delineated by the frame looks similar to the compression curl often seen in bend bars. Such curved surfaces generally arise from mixed mode loading (tension, shear, torsion), and are found to be typical of final crack break-through in dental crowns. Higher magnifications within the frame (Figs.5b,c) near the interproximal mesial margin show hackle and wake hackle indicating the direction of crack propagation towards the margin.

a: Occlusal view (at 10x) of the Procera AllCeram crown showing the veneer failure on the palatal-mesial cusp. Major wear is visible on all four cusps. The frame near the mesial gingival margin is magnified in Fig.5b and Fig.5c

b and c: Higher magnifications within the frame (Fig.5a) near the interproximal mesial margin show hackle and wake hackle indicating the direction of crack propagation towards the margin.

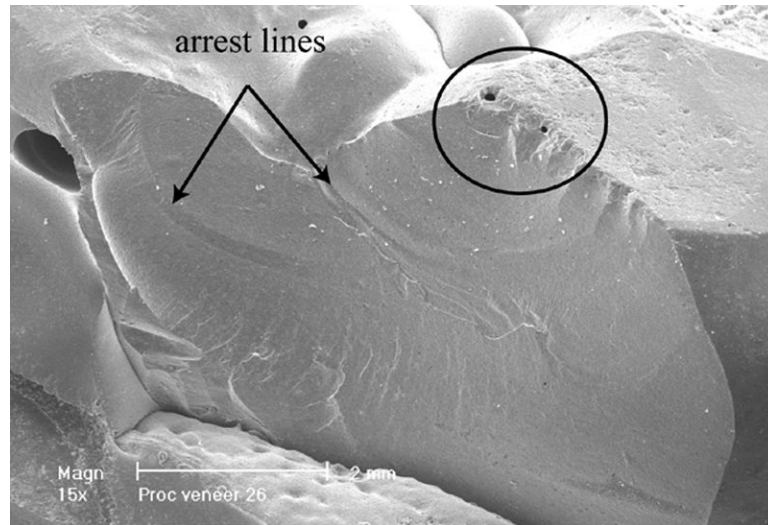
On the fractured surface viewed at 15x magnification (Fig.6) several major *arrest lines* are observable. The occlusal edge of the palatal cusp (circle) is shown under higher magnification in Figs.7 and 8. On the edge of the fractured surface (large frame in Fig.7) an area of erosive wear spanning about one millimeter is delimited by concave *arrest lines*. At 127x magnification (Fig.8), this area comprises two deeper damage zones shaped as indents (craters) about 300 μm in diameter followed by *arrest lines* further downwards. These craters are identified as the origins of the fracture process.

Fig. 6. Side view of the Procera AllCeram crown (at 15x). Major arrest lines are recognizable as well as hackle lines. The circled occlusal broken edge shows some surface damage.

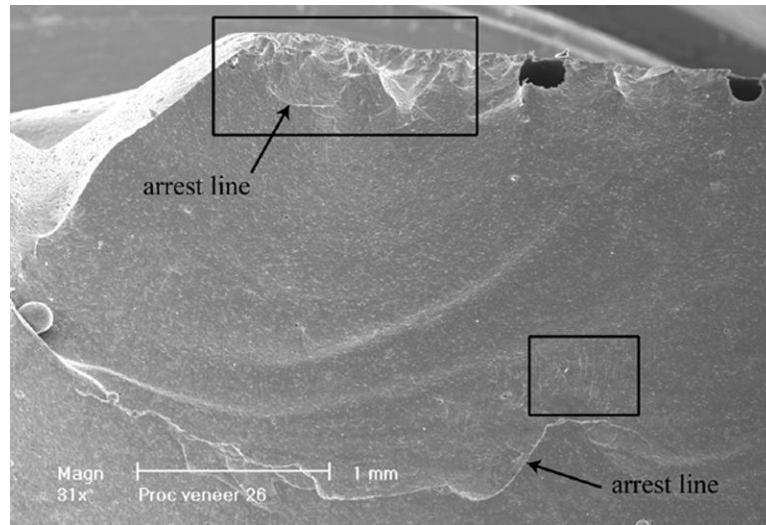
Fig. 7. Higher magnification (31x) of the circled area in Fig.6. Several arrest lines are visible (concave well delimited lines). Areas of interest (frames) are scrutinized at higher magnifications in the following figures.

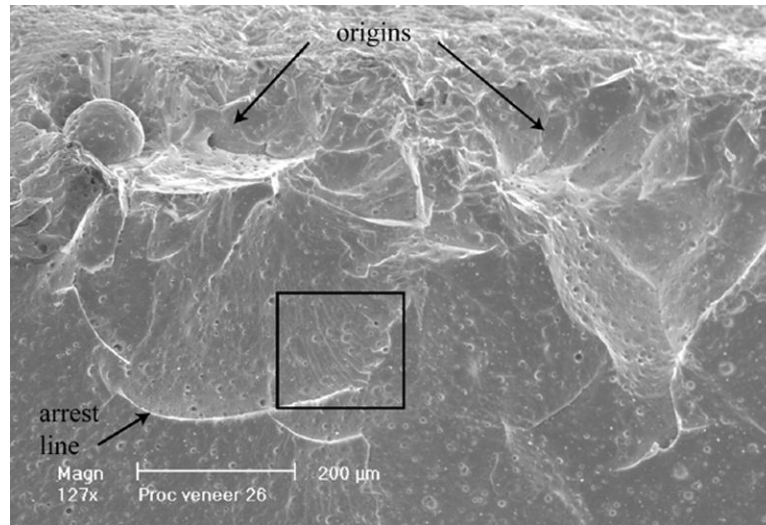
Fig. 8. Detailed view (127x) of the occlusal damaged edge (larger frame in Fig.7). Two indented (crater type) areas are identified as the origin sites from which failure started followed by an arrest line. The area near the arrest line delimited by a frame is blown-up in Fig. 9.

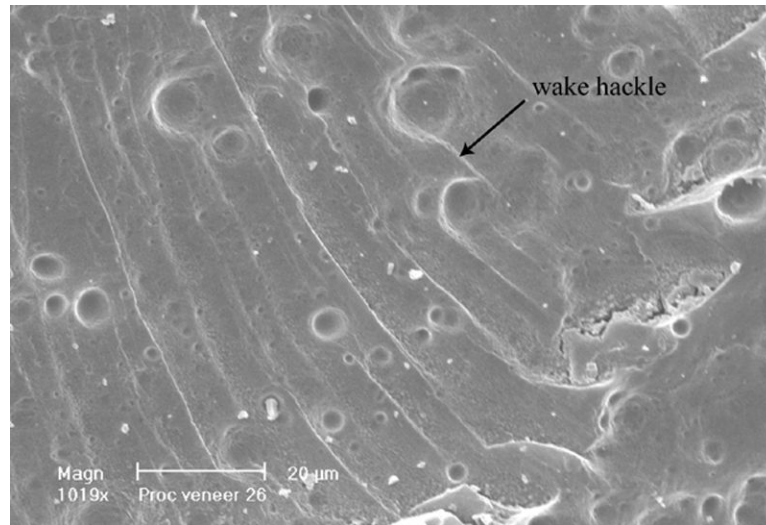
Figure 9 is a further magnification (1029x) of the frame delimited area next to an arrest line in Fig.8 and shows numerous *wake hackle* emanating from porosities within the veneering ceramic (AllCeram). The trailing character of these lines indicates that the crack front was running from top left to bottom right at this specific site, that is, occlusoapically towards the gingival margin of the crown. Figure 10 is a higher magnification (252x) of the area within the smaller frame in Fig. 7. Here also a number of *wake hackle* indicate the direction of fracture propagation (top to bottom). Figure 11 is an occlusal view at 31x magnification of the fracture origin demonstrating its location within an occlusal wear facet. Also visible on this figure are three holes (i.e. the black spots) where the epoxy resin did not adequately wet the impression during pouring of the replica. Finally, Fig.12 is a synopsis of the failure process. The origin of the fracture is circled on the palatal cusp. The general direction of crack propagation is marked by the arrows pointing towards the crown margin.

Fig. 9. High magnification at 1019x of the frame in Fig.8. Many wake hackle are visible starting from pores within the Procera veneering porcelain (AllCeram). The direction of propagation goes from top to bottom along the trail of the wake hackle.

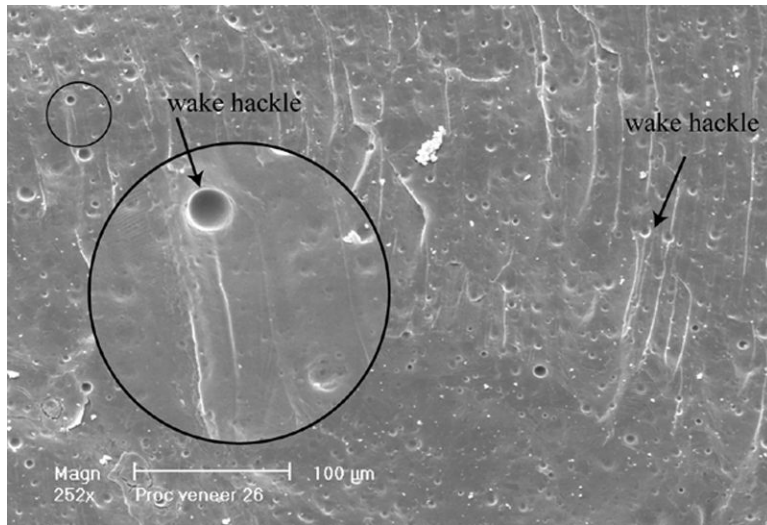
Fig. 10. Higher magnification of the smaller frame area in Fig. 7. Wake hackle are clearly recognizable indicating the direction of crack propagation (from top to bottom i.e. from occlusal surface to gingival margins).

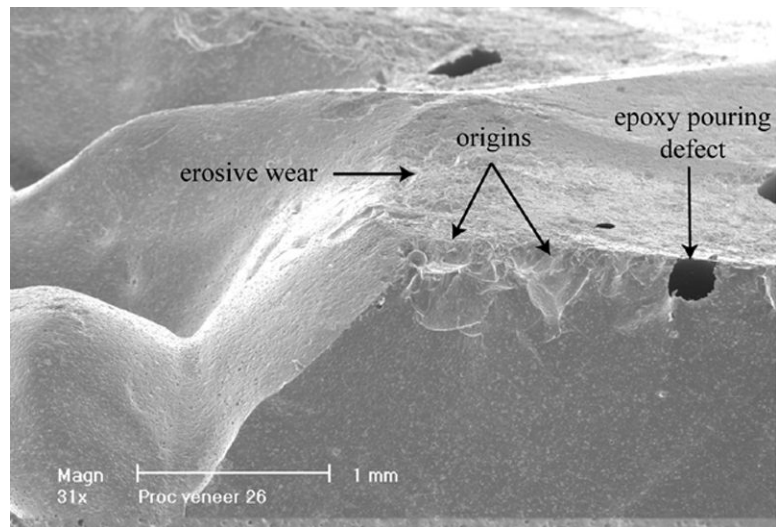
Fig. 11. Additional occlusal view at an angle and low magnification (31x) of the crack initiation sites (origins). Note the occlusal worn ceramic surface and resin pouring artifacts (black spots) resulting from poor resin wetting at sharp angles of the replica impression.

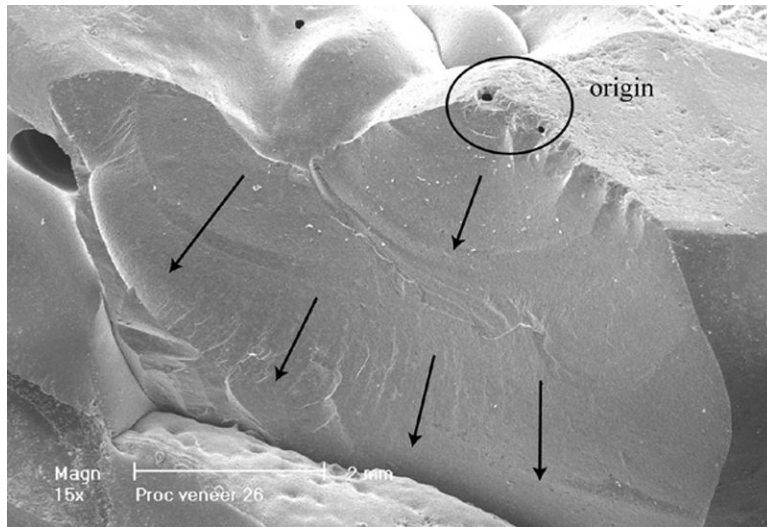
Fig. 12. Summary image with circled area for crack initiation and arrows indicating the general direction of crack propagation.

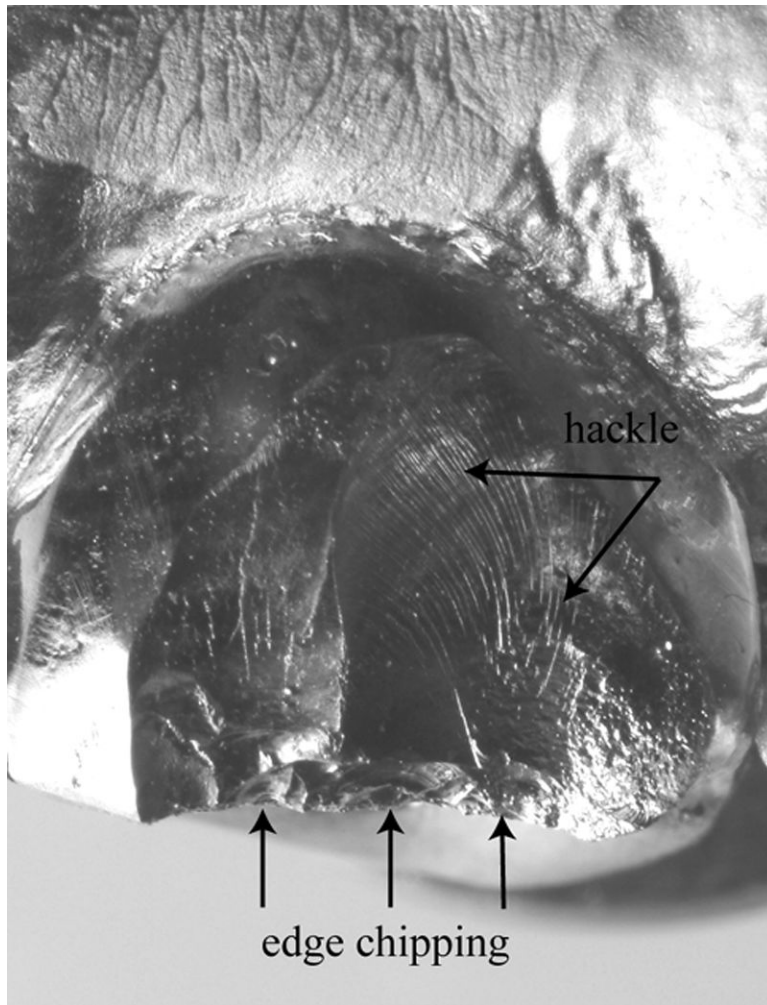
Visual observation of the gold-coated replica (Fig. 13) of the fractured In-Ceram Zirconia upper premolar crown indicates a major chip of the veneering ceramic on the buccal side. Numerous hackle lines curling off towards the gingival margins as well as several smaller ceramic chips on the cusp tip are observable. Fig. 14 (18x) shows a worn cusp tip with several small ceramic chips delimited by concave *arrest lines* on the buccal surface. The higher magnification on the right of the picture shows several *wake hackle* emanating from existing pores. Figure 15 is a close up view of the frame in Fig.14 showing a 97x magnification of the worn and damaged

Fig. 13. Gold-coated replica of an In-Ceram Zirconia veneering porcelain fracture of an upper first premolar. The naked eye recognizes many hackle lines and a damaged buccal edge with several smaller edge chips.

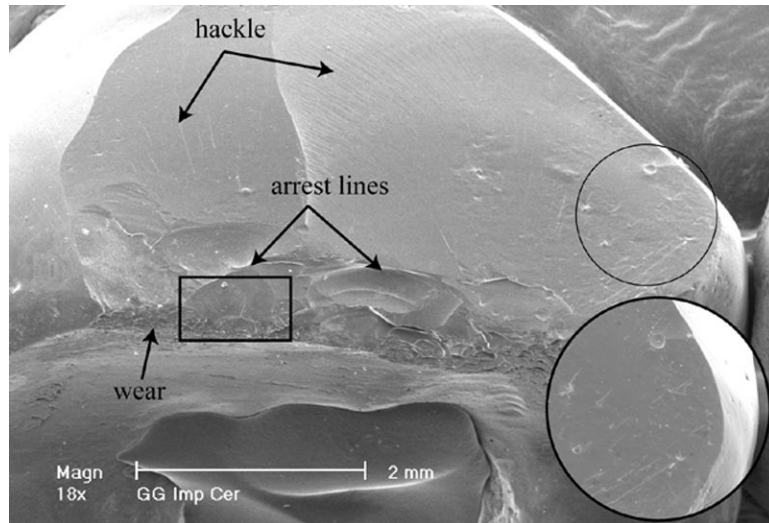
Fig. 14. The SEM view at 18x shows evidence of ceramic wear near the fractured edge, arrest lines, hackle and wake hackle (zoom within the image). The frame area is analyzed in Fig. 15.

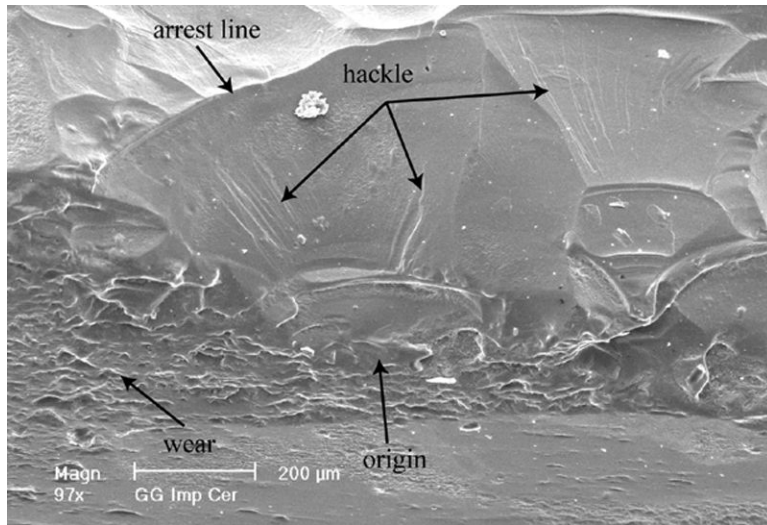
Fig. 15. Higher magnification (97x) of the frame delimited occlusal edge area in Fig. 14 showing many arrest lines, hackle, wear and one of several origins on that edge.

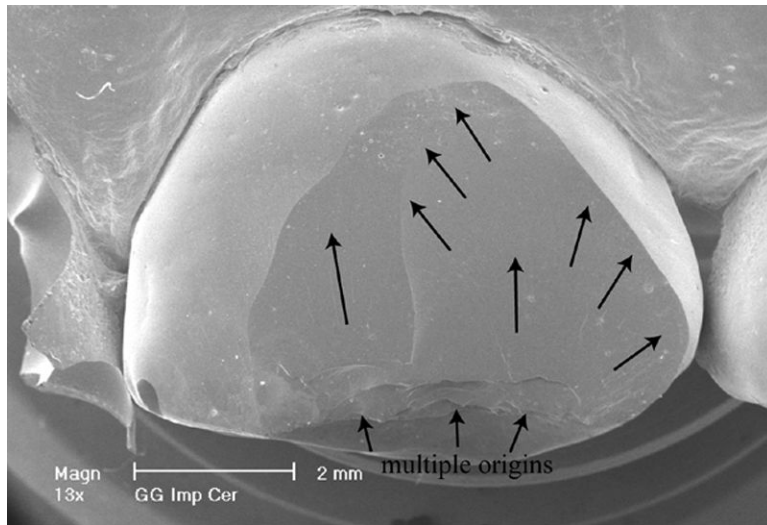
cuspid tip with *arrest-* and *hackle lines*. A comprehensive view of the direction of crack propagation and multiple origins (arrows on cuspid tip) is given in Fig. 16.

In the second case (fracture of the veneering porcelain of an In-Ceram Zirconia crown screwed-fastened to an implant), failure occurred after two months of intraoral function only. Fractographic analysis revealed that the crack origin was located at the buccal cuspid tip next to occlusal guiding facets. The buccal cuspid of this crown had been modeled too long by the technician and was under permanent shear load during lateral excursions. The worn surface next to the initiation sites (origins) is an indicator of the functional and parafunctional activity on the crown. In this instance, an optimized design of the crown's anatomy regarding guidance planes during lateral excursions may have prevented this early chipping. Technically, the problems encountered with replicas are the presence of artifacts such as air bubbles trapped within the epoxy resin or an incomplete pouring of sharp angles. Such artifacts, however, are usually minute and only seldom mask the key features of the fractured surface. Other limitations of replicas such as their inability to determine subsurface features via transmission or transillumination, their inability to use color as an indication of material changes and some blurring of very small features have been mentioned [7] but are usually not critical. Very fine detailed markings viewed at 4027x in Fig.17 (a magnification of Fig.10) were possible with the replica. The image shows perpendicular ripples or stairline striations next to a *wake*

Fig. 16. Summary of the failure event with the initiation site on the occlusal buccal edge (cusp tip) and the crack front moving along the arrowed path towards the gingival margins.

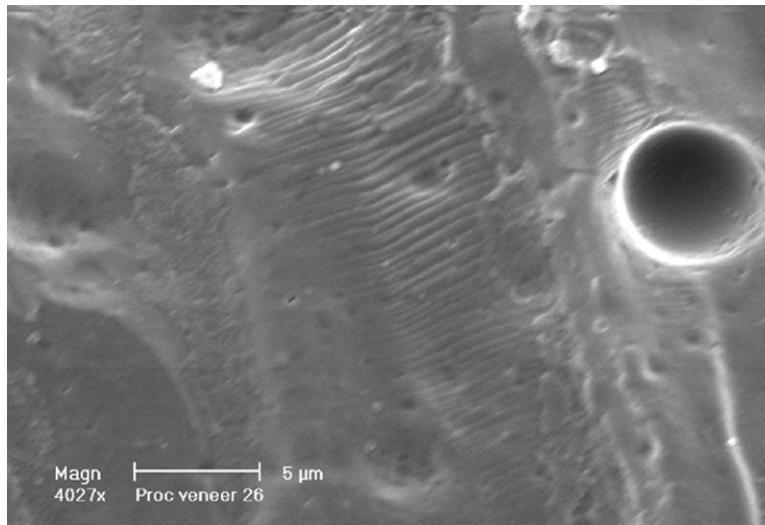
hackle. These ripples have been identified as secondary *twist hackle* from lateral link up of overlapping crack segments [9]. These may occur when multiple crack planes are present.

Fig. 17. The clear details obtained from replicas viewed here at 4027x. Twist hackle looking like ripples are visible perpendicular to a wake hackle (detailed view of Fig. 10). The twist hackle are obtained from final lateral link up of overlapping crack segments.
