Fractographic ceramic failure analysis using the replica technique

Susanne S. Scherrer^a, Janet B. Quinn^b, George D. Quinn^c, and H. W. Anselm Wiskott^a

Objectives—To demonstrate the effectiveness of in vivo replicas of fractured ceramic surfaces for descriptive fractography as applied to the analysis of clinical failures.

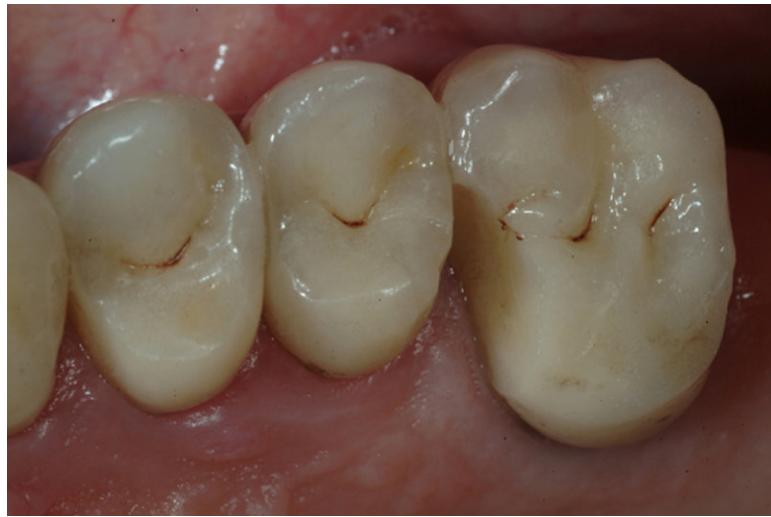
Fig. 1.

Fracture of the veneering porcelain (AllCeram) of an upper left Procera alumina molar after 4.2 years of intra-oral function

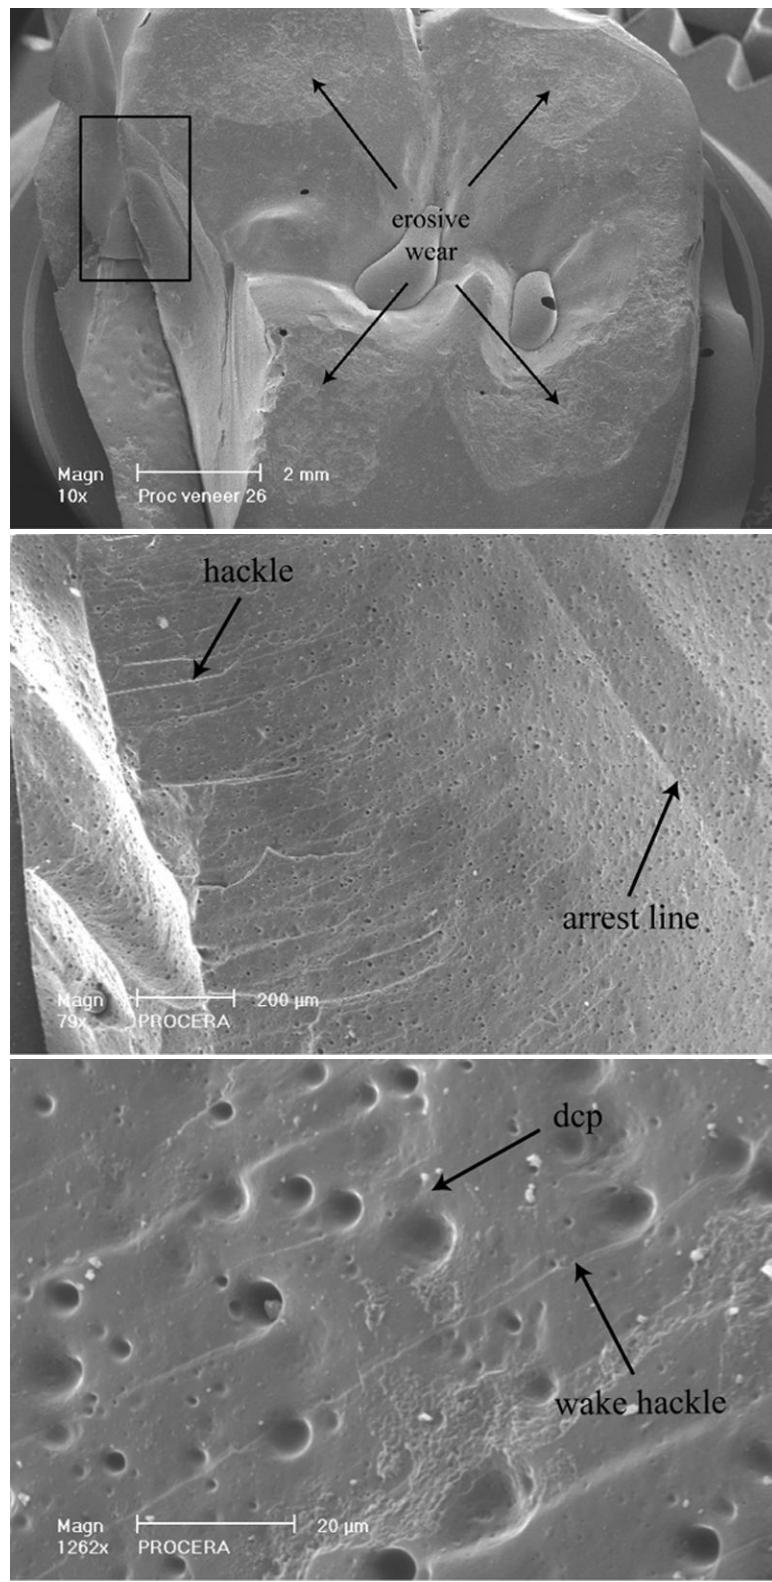
Fig. 5.

The resin replica (Fig.4) of the failed Procera AllCeram crown was sputter-coated with gold and inspected under SEM magnification. Figure 5a shows the crown from an occlusal view at low power (10x). Major erosive wear is apparent on all four cusps, usually a sign of abnormal parafunction habits (bruxism). The zone delineated by the frame looks similar to the compression curl often seen in bend bars. Such curved surfaces generally arise from mixed mode loading (tension, shear, torsion), and are found to be typical of final crack break-through in dental crowns. Higher magnifications within the frame (Figs.5b,c) near the interproximal mesial margin show hackle and wake hackle indicating the direction of crack propagation towards the margin.

a: Occlusal view (at 10x) of the Procera AllCeram crown showing the veneer failure on the palatal-mesial cusp. Major wear is visible on all four cusps. The frame near the mesial gingival margin is magnified in Fig.5b and Fig.5c

b and c: Higher magnifications within the frame (Fig.5a) near the interproximal mesial margin show hackle and wake hackle indicating the direction of crack propagation towards the margin.

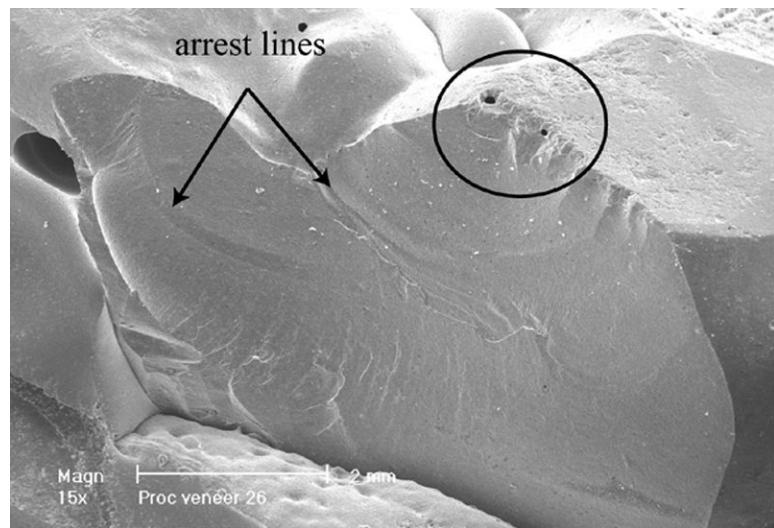
Fig. 6.

Side view of the Procera AllCeram crown (at 15x). Major arrest lines are recognizable as well as hackle lines. The circled occlusal broken edge shows some surface damage.

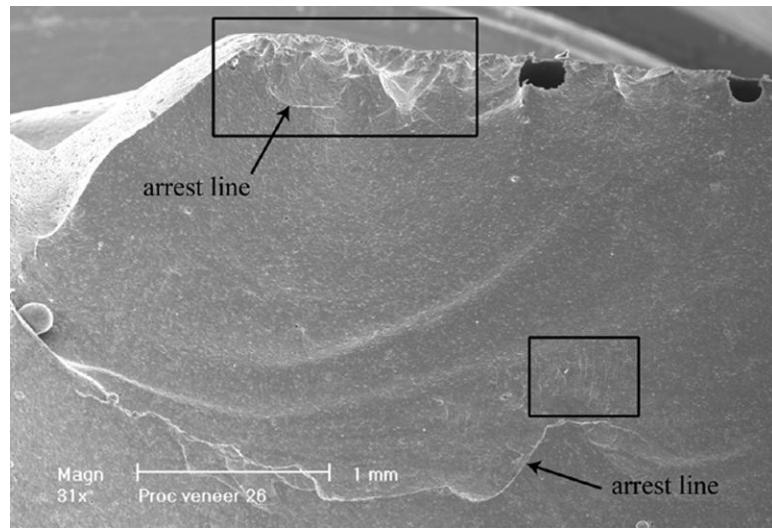
Fig. 7.

Higher magnification (31x) of the circled area in Fig.6. Several arrest lines are visible (concave well delimited lines). Areas of interest (frames) are scrutinized at higher magnifications in the following figures.

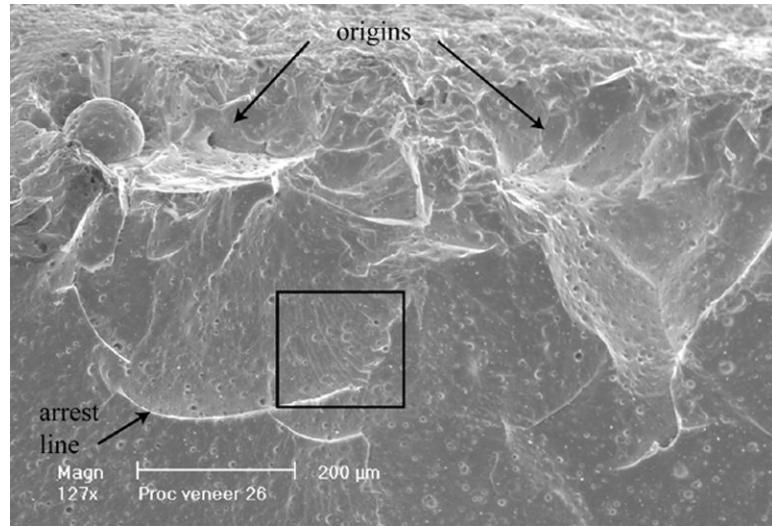
Fig. 8.

On the fractured surface viewed at 15x magnification (Fig.6) several major *arrest lines* are observable. The occlusal edge of the palatal cusp (circle) is shown under higher magnification in Figs.7 and 8. On the edge of the fractured surface (large frame in Fig.7) an area of erosive wear spanning about one millimeter is delimited by concave *arrest lines*. At 127x magnification (Fig.8), this area comprises two deeper damage zones shaped as indents (craters) about 300 μm in diameter followed by *arrest lines* further downwards. These craters are identified as the origins of the fracture process.

Detailed view (127x) of the occlusal damaged edge (larger frame in Fig.7). Two indented (crater type) areas are identified as the origin sites from which failure started followed by an arrest line. The area near the arrest line delimited by a frame is blown-up in Fig. 9.

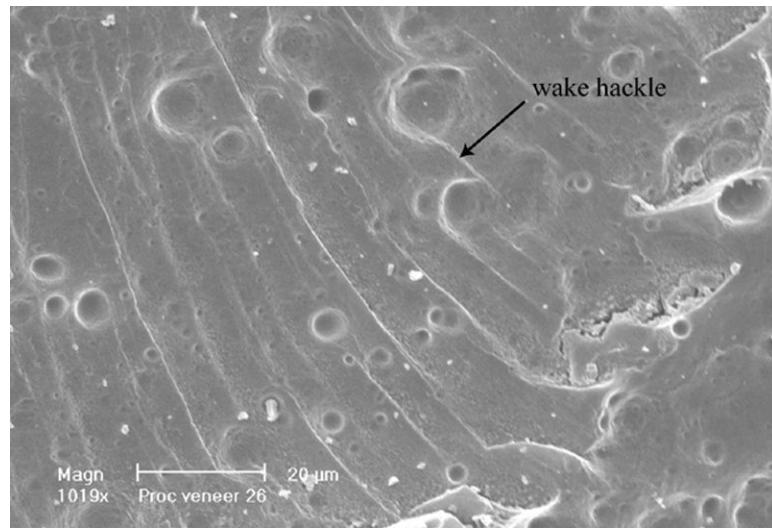
Fig. 9.

Figure 9 is a further magnification (1029x) of the frame delimited area next to an arrest line in Fig.8 and shows numerous *wake hackle* emanating from porosities within the veneering ceramic (AllCeram). The trailing character of these lines indicates that the crack front was running from top left to bottom right at this specific site, that is, occlusoapically towards the gingival margin of the crown. Figure 10 is a higher magnification (252x) of the area within the smaller frame in Fig. 7. Here also a number of *wake hackle* indicate the direction of fracture propagation (top to bottom). Figure 11 is an occlusal view at 31x magnification of the fracture origin demonstrating its location within an occlusal wear facet. Also visible on this figure are three holes (i.e. the black spots) where the epoxy resin did not adequately wet the impression during pouring of the replica. Finally, Fig.12 is a synopsis of the failure process. The origin of the fracture is circled on the palatal cusp. The general direction of crack propagation is marked by the arrows pointing towards the crown margin.

High magnification at 1019x of the frame in Fig.8. Many wake huckle are visible starting from pores within the Procera veneering porcelain (AllCeram). The direction of propagation goes from top to bottom along the trail of the wake huckle.

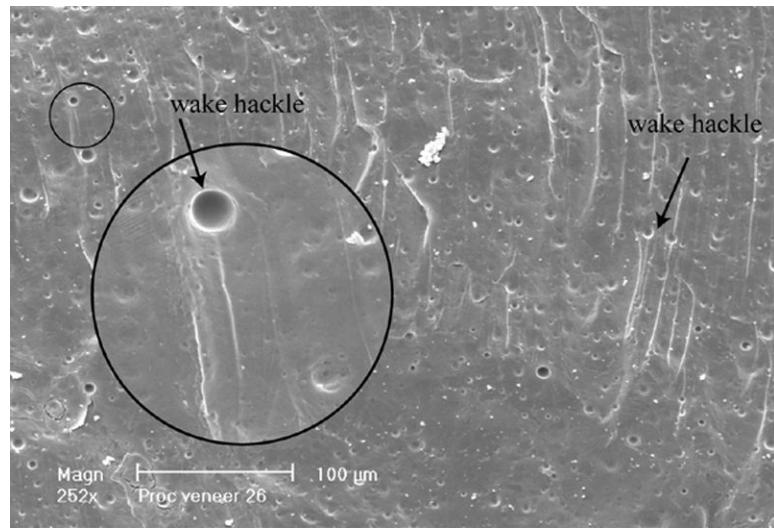
Fig. 10.

Higher magnification of the smaller frame area in Fig. 7. Wake hake are clearly recognizable indicating the direction of crack propagation (from top to bottom i.e. from occlusal surface to gingival margins).

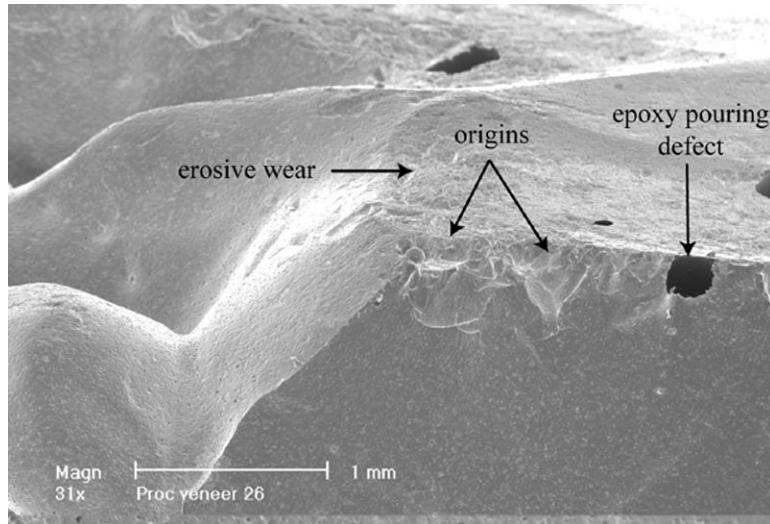
Fig. 11.

Additional occlusal view at an angle and low magnification (31x) of the crack initiation sites (origins). Note the occlusal worn ceramic surface and resin pouring artifacts (black spots) resulting from poor resin wetting at sharp angles of the replica impression.

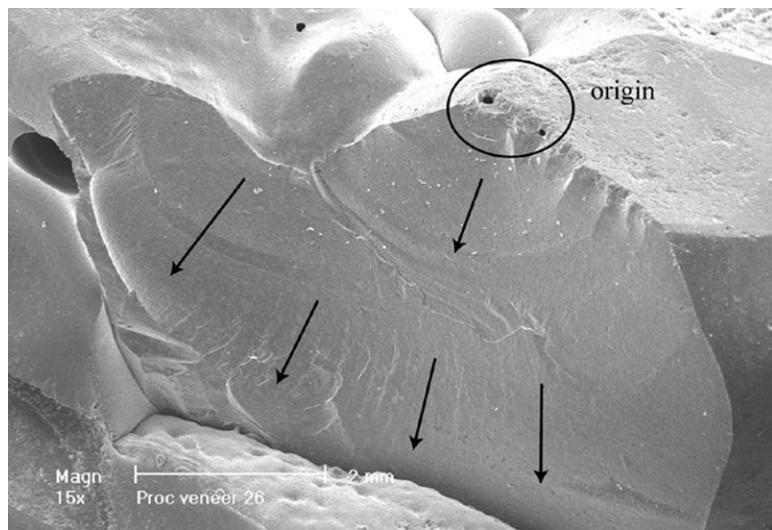
Fig. 12.

In the first case, (Procera AllCeram) the veneering ceramic failed after approximately four years of intraoral function. It could be inferred from the worn occlusal surface pictured on the SEM that this patient had strong bruxing habits (that means a highly stressed crown). It appears that the fairly thick layer of unsupported veneering ceramic (2-3mm) combined to the repetitive loadings generated while the patient was bruxing promoted the initiation of a crack which resulted in the catastrophic failure of the restoration. The two indents at the origin of the fracture may be explained by the patient inadvertently biting on a hard particle. With respect to the unsupported veneering ceramic, newer core design procedures such as double scanning should prevent excessive thicknesses of the (mechanically weak) veneering ceramic.

Summary image with circled area for crack initiation and arrows indicating the general direction of crack propagation.

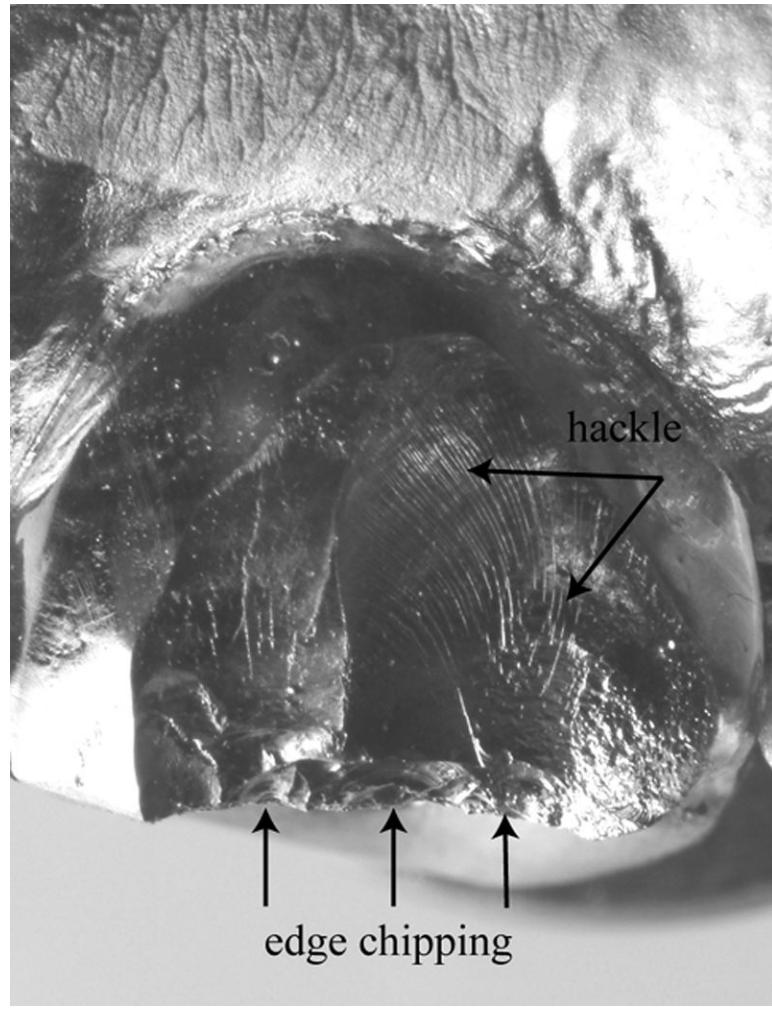
Fig. 13.

Visual observation of the gold-coated replica (Fig. 13) of the fractured In-Ceram Zirconia upper premolar crown indicates a major chip of the veneering ceramic on the buccal side. Numerous hackle lines curling off towards the gingival margins as well as several smaller ceramic chips on the cusp tip are observable. Fig. 14 (18x) shows a worn cusp tip with several small ceramic chips delimited by concave *arrest lines* on the buccal surface. The higher magnification on the right of the picture shows several *wake hackle* emanating from existing pores. Figure 15 is a close up view of the frame in Fig.14 showing a 97x magnification of the worn and damaged

Gold-coated replica of an In-Ceram Zirconia veneering porcelain fracture of an upper first premolar. The naked eye recognizes many hackle lines and a damaged buccal edge with several smaller edge chips.

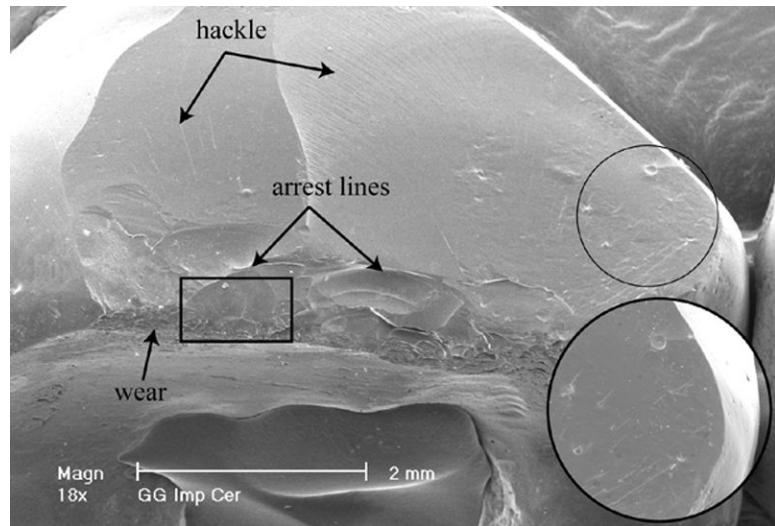
Fig. 14.

The SEM view at 18x shows evidence of ceramic wear near the fractured edge, arrest lines, hackle and wake hackle (zoom within the image). The frame area is analyzed in Fig. 15.

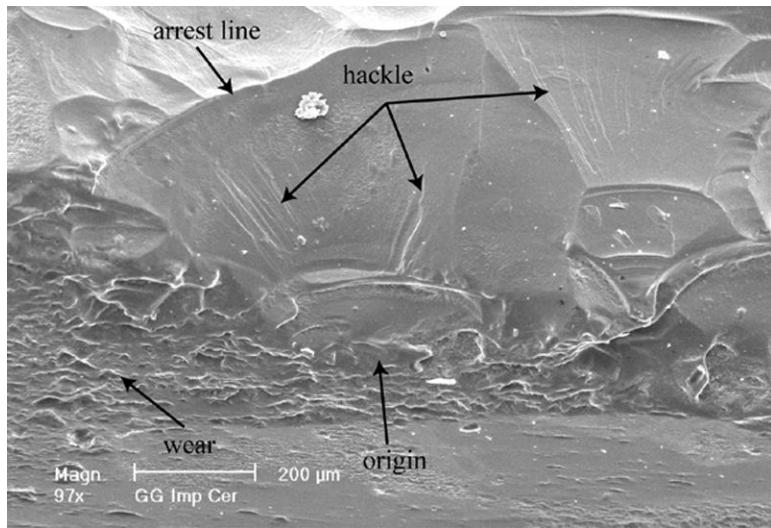
Fig. 15.

Higher magnification (97x) of the frame delimited occlusal edge area in Fig. 14 showing many arrest lines, hackle, wear and one of several origins on that edge.

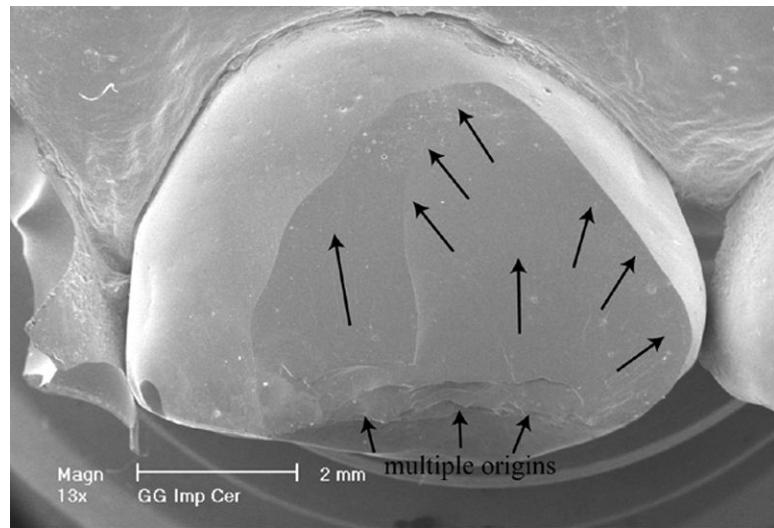
cusp tip with *arrest-* and *hackle lines*. A comprehensive view of the direction of crack propagation and multiple origins (arrows on cusp tip) is given in Fig. 16.

In the second case (fracture of the veneering porcelain of an In-Ceram Zirconia crown screwed-fastened to an implant), failure occurred after two months of intraoral function only. Fractographic analysis revealed that the crack origin was located at the buccal cusp tip next to occlusal guiding facets. The buccal cusp of this crown had been modeled too long by the technician and was under permanent shear load during lateral excursions. The worn surface next to the initiation sites (origins) is an indicator of the functional and parafunctional activity on the crown. In this instance, an optimized design of the crown's anatomy regarding guidance planes during lateral excursions may have prevented this early chipping. Technically, the problems encountered with replicas are the presence of artifacts such as air bubbles trapped within the epoxy resin or an incomplete pouring of sharp angles. Such artifacts, however, are usually minute and only seldom mask the key features of the fractured surface. Other limitations of replicas such as their inability to determine subsurface features via transmission or transillumination, their inability to use color as an indication of material changes and some blurring of very small features have been mentioned [7] but are usually not critical. Very fine detailed markings viewed at 4027x in Fig.17 (a magnification of Fig.10) were possible with the replica. The image shows perpendicular ripples or stairline striations next to a *wake*

Summary of the failure event with the initiation site on the occlusal buccal edge (cusp tip) and the crack front moving along the arrowed path towards the gingival margins.

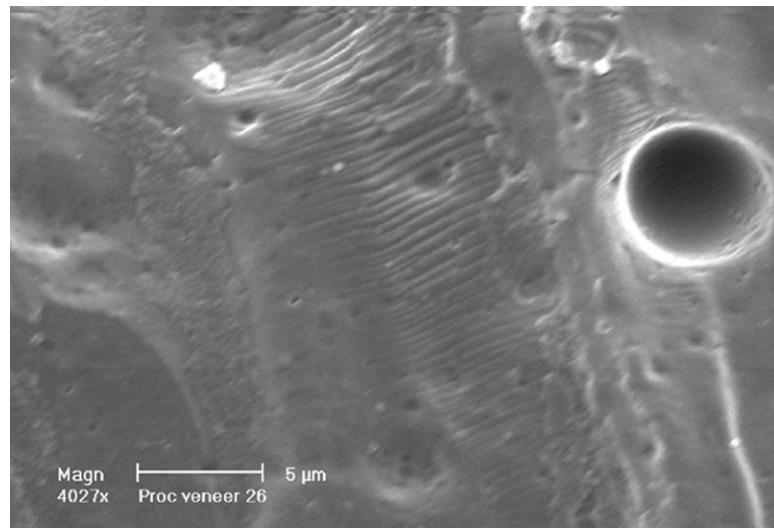
Fig. 17.

hackle. These ripples have been identified as secondary *twist hackle* from lateral link up of overlapping crack segments [9]. These may occur when multiple crack planes are present.

The clear details obtained from replicas viewed here at 4027x. Twist hackle looking like ripples are visible perpendicular to a wake hackle (detailed view of Fig. 10). The twist hackle are obtained from final lateral link up of overlapping crack segments.
