## Regional reconstruction of flash flood history in the Guadarrama range (Central System, Spain)

RODRIGUEZ MORATA, Clara et al. Regional reconstruction of flash flood history in the Guadarrama range (Central System, Spain). In: Science of the total environment, 2016, vol. 550, p. 406–417. doi: 10.1016/j.scitotenv.2016.01.074

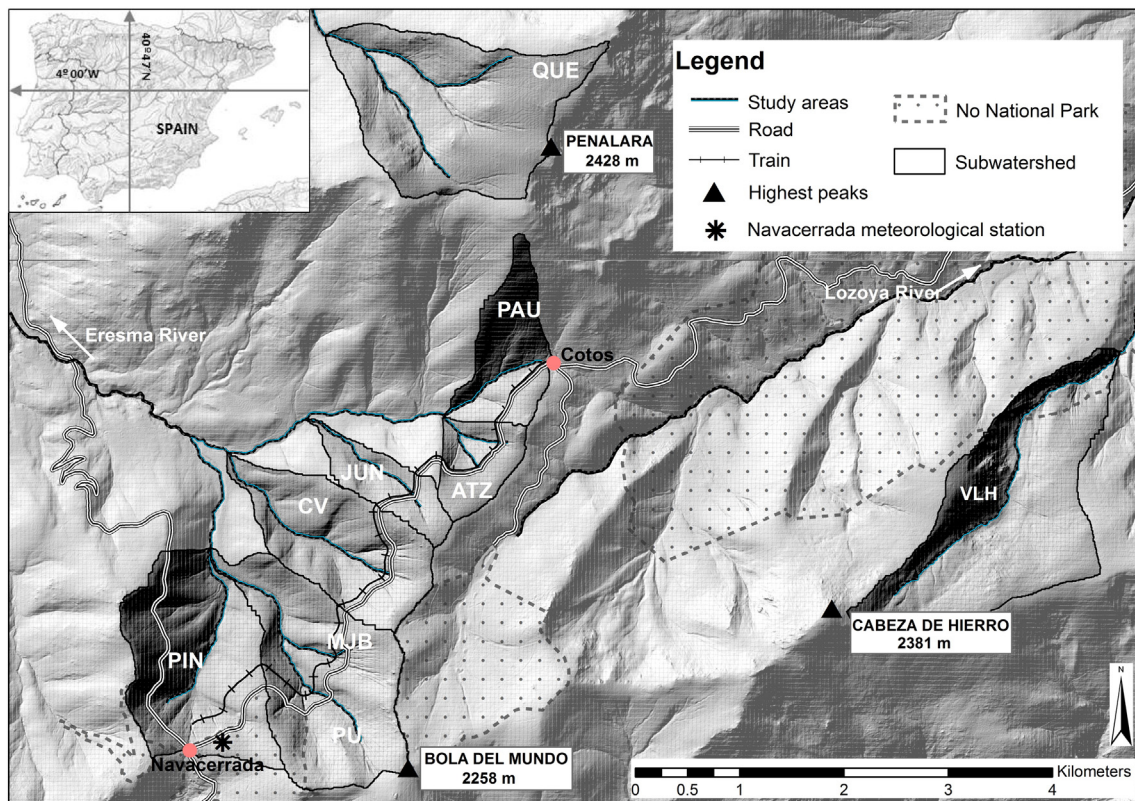
Fig. 1. Location of the study streams. Highlighted areas represent the study watersheds. Dotted polygons show areas which are not inside the National Park. Triangles mark the location of the highest peaks in the study area: Peñalara, Cabeza de Hierro and Bola del Mundo.

The mountain catchments under investigation are located in the Guadarrama Mountain range (Spanish Central System; Fig. 1) which extends in a southwest to northeast direction for about 80 km, thereby dividing the Duero Basin (northwest) from the Tagus Basin (southeast). The range has a maximum altitude of 2428 m a.s.l. (Peñalara peak, Fig. 1). A total of seven adjoining catchments have been selected for this study, namely the Quebradas (QUE), Paular (PAU), Altozano (ATZ), Juncional (JUN), Cárcavas Del Valle (CV), Pintadas (PIN) and Valhondillo (VLH) streams. Moreover, we compare data reconstructed for these streams with results from existing dendrogeomorphic analyses of the adjacent Puentes (PU) and Majabarca (MJB) catchments (Ballesteros-Cánovas et al., 2015b).

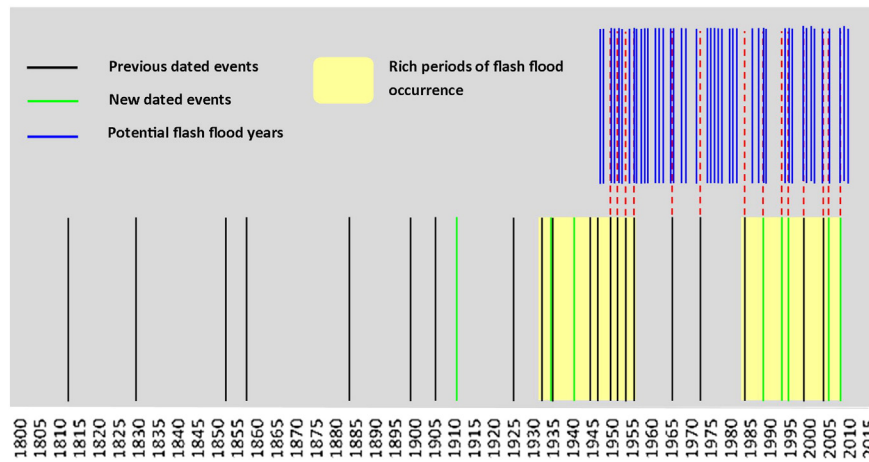
**Fig. 2.** Flash floods dated in the region between 1800 and 2014. Green lines show the new dated events in this study. Black lines represent the events reported by Ballesteros-Cánovas et al. (2015b). Yellow shadows highlight rich periods of occurrence: 1933–1956 and 1989–2008. And, related with the results in Section 4.4, the time line above is showing the 14 dated events (red dashed lines) using tree rings and the years in which the rainfall thresholds were exceeded one or more times (blue lines) since 1946.

The partial minimal occurrence at all study sites is at a higher level between 1933 and 1956 with at least 10 events in 23 years ( $0.39$  events  $\text{yr}^{-1}$ ). Above-average occurrence in events is also observed in the period 1989–2008 with 8 events in 19 years ( $0.37$  events  $\text{yr}^{-1}$ ) (Fig. 2).

By contrast, 14 of the events dated in this study represent 20% of the years covered by the period for which gauging records exist (Fig. 2). In this respect, the analysis also shows that the threshold was more frequently exceeded in fall ( $70.0 \pm 7.8$  times) and spring ( $43.3 \pm 15.2$  times) than in winter ( $9.0 \pm 1.7$  times) (Table 7). A more detailed assessment shows that the months of April (58 times), May (59 times), October (84 times), and November (69 times) were those months with the largest number of exceedances.

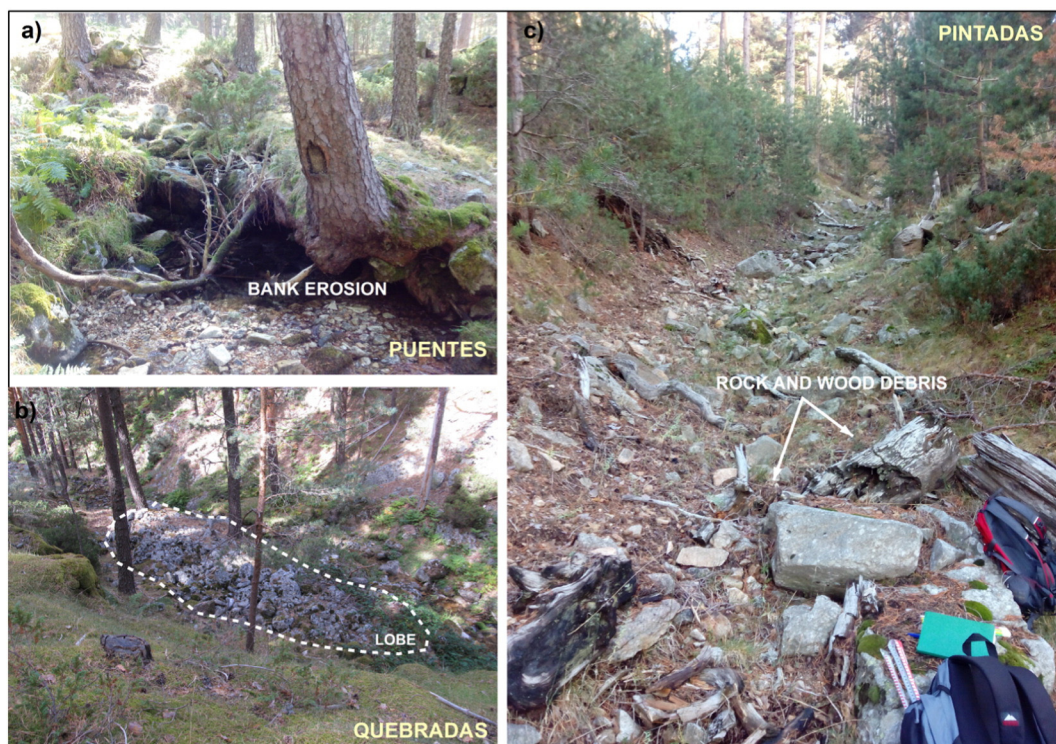
**Fig. 3.** Pictures showing different sediment sources from three torrents (PU, QUE, and PIN).

Field surveys also revealed that sediment transported by flash floods mainly stems from channel banks (Fig. 3a) or old flash-flood deposits like levees or lobes (Fig. 3b). Field observations furthermore show that coarse sediment and woody debris remaining in the channel can be mobilized during events as well (Fig. 3c).

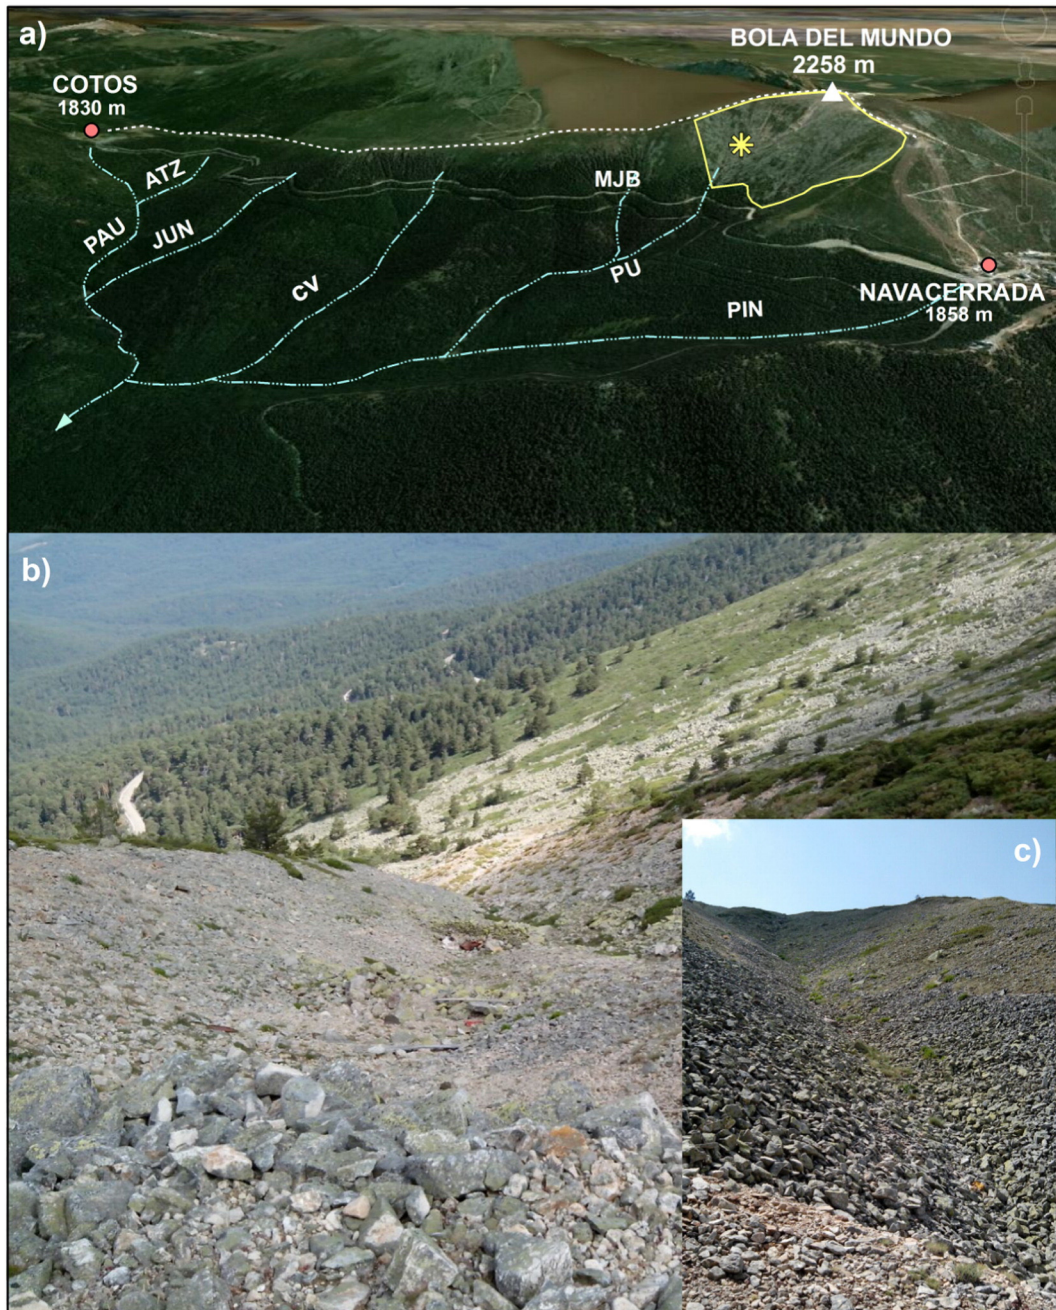
**Fig. 4.** View of the top of the Puentes stream. a) Situation in the study area. b), c) Pictures taken from the yellow-star showing the unconsolidated deposit and the pronounced slope steepness. The vegetation is sparse through to the start of the tree line.

However, in the case of catchment PU, which is by far the most active catchment according to our analysis, unconsolidated material of periglacial origin ( $89 \text{ ha}$ ) yet forms another big source of sediment (yellow polygon in Fig. 4a) with important, quasi-permanent sub-superficial runoff.

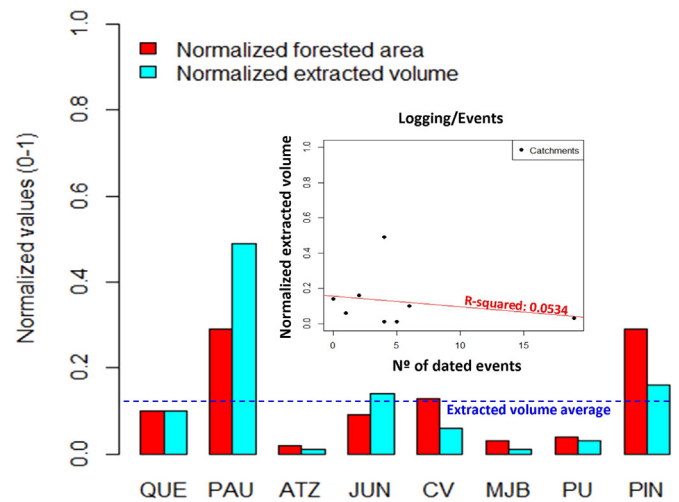
Fig. 5. Graphic representation of the relationship between the normalized values of forested area and wood extracted volume in each catchment with the events dated for these sites. Blue dashed line is representing the wood extracted volume average ( $0.13$ ).

Analysis of the volumes of wood extracted from the catchments under investigation showed dissimilar patterns throughout the period covered (1940–2009; no data for VLH; Fig. 5).

The total volume of extracted wood in all catchments was  $179,438 \text{ m}^3$ . Extraction was very different between catchments and most important in PAU with almost  $87,950 \text{ m}^3$  (49% of the total volume), whereas the lowest amount was extracted in ATZ with only  $1277 \text{ m}^3$  (1% of the total). In addition, the scatter plot in Fig. 5 clearly indicates a negative correlation ( $\rho = -0.231$  and  $R^2 = 0.0534$ ) between the number of dated events and the normalized volume of extracted wood in each catchment.

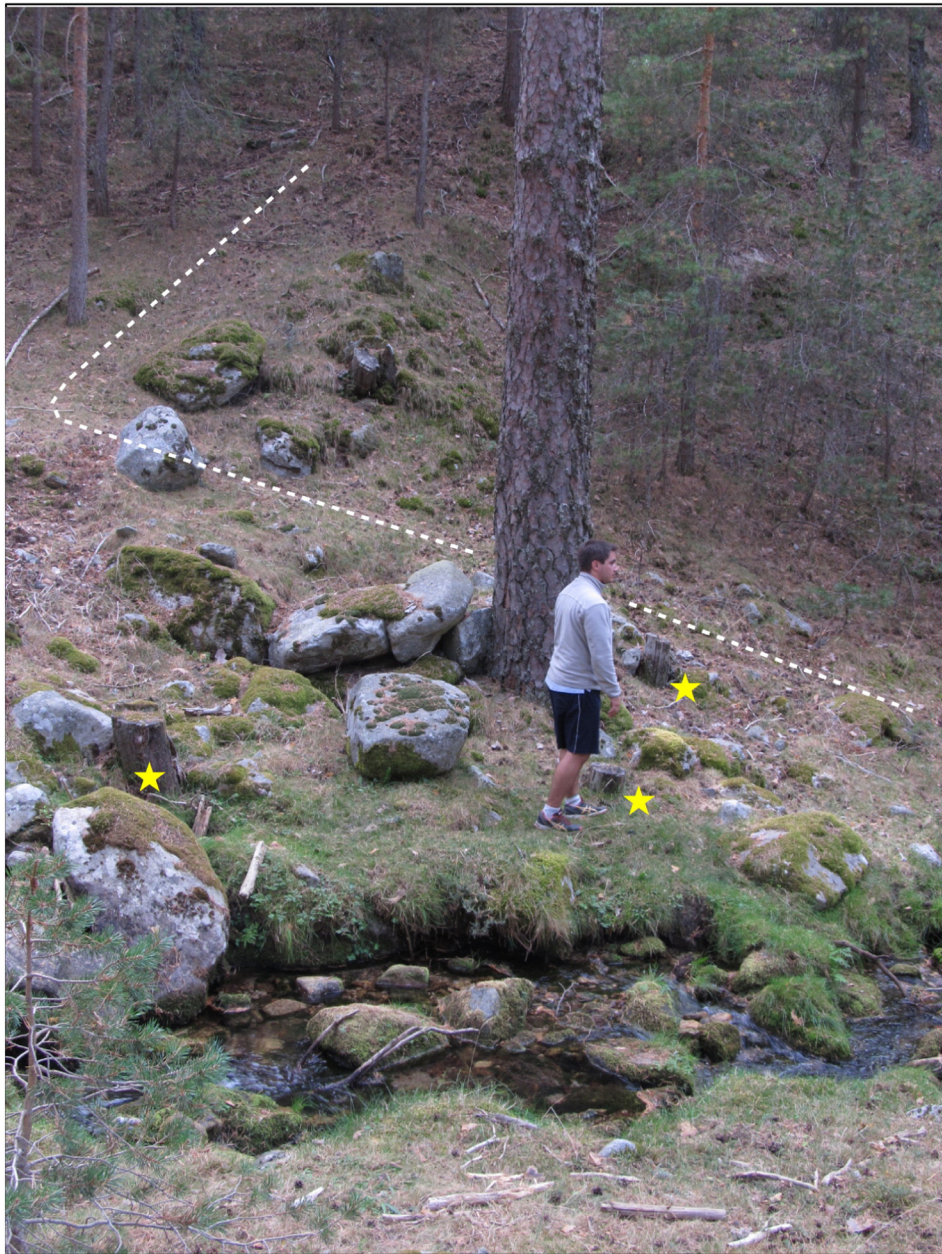
**Fig. 6.** Picture taken in QUE torrent, providing an example of the generalized harvesting activity in the study areas. Yellow stars indicate stumps close to the channel. White dotted lines highlight the out-wood path. The tree in the image is a good example of a tree not suited for dendrogeomorphologic analyses. This is because, despite its proximity to the stream, the tree ring record of this tree possibly exhibit noise related to several causes: 1) logging of its immediate neighbours may result in a strong increment in the growth of the tree-rings; 2) the logging trees removed through the out-wood path and the equipment used for this purpose can damage this tree leaving signals similar to the ones left by flash flood activity; 3) The rocks impacting the stem probably come from the cleaning of the out-wood path, thus leading to possibly erroneous interpretations about its origin.

The existence of stumps near the current position of streams in the catchments (Fig. 6) and the comparison of vegetation cover evolution based on aerial photography also suggests that forest management works included areas close to the stream channels (Table 5).

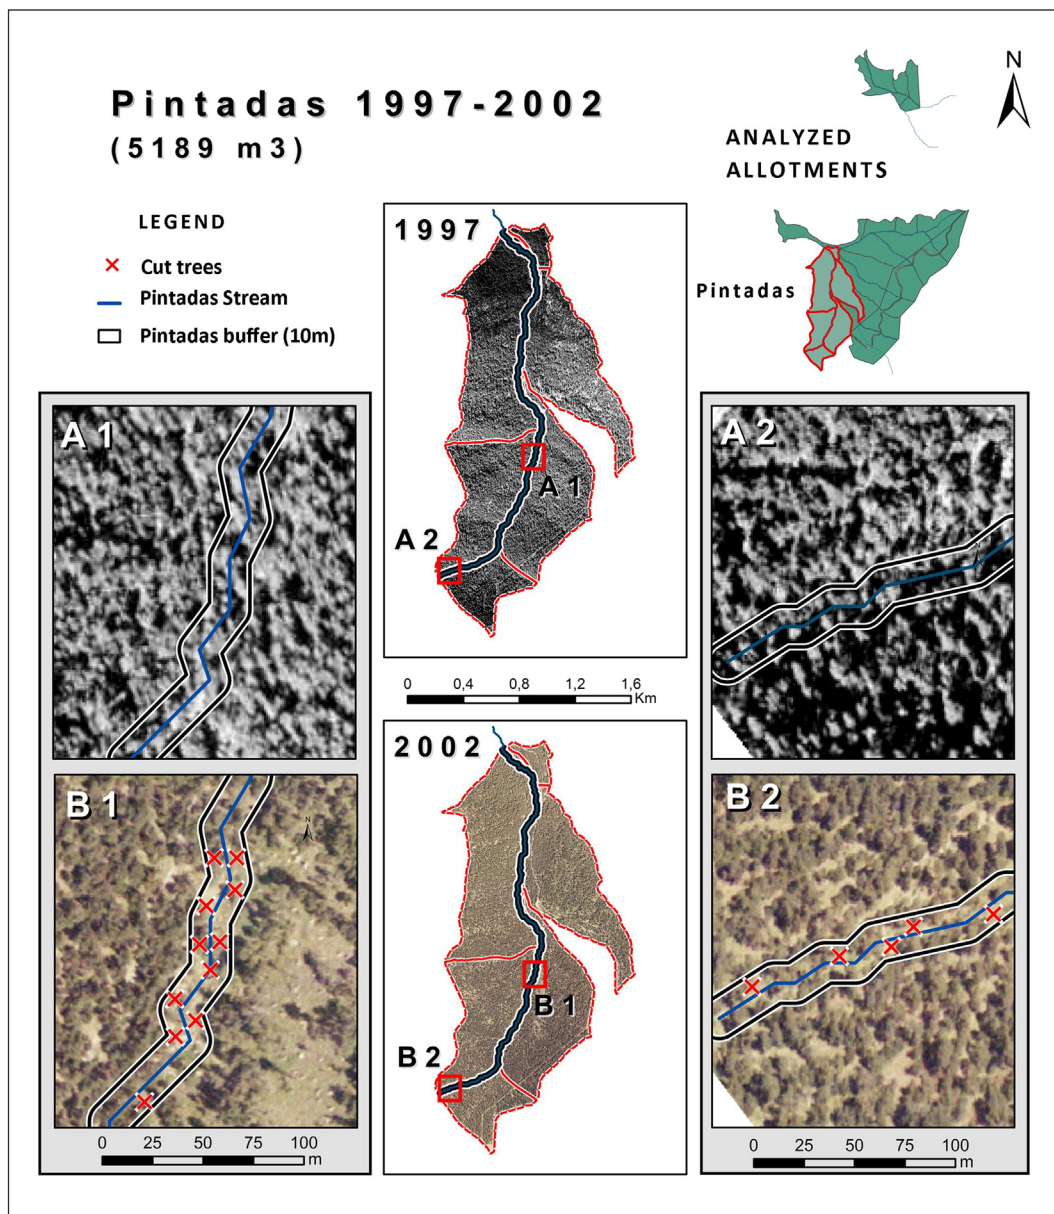
**Fig. 7.** These pictures are an example from the PIN catchment showing the variation of the vegetation between 1997 and 2002. During this time lapse, 5189 m<sup>3</sup> of wood was extracted from the PIN allotments cantons. A large space without trees appears in the middle part of the torrent in 2002 (boxes A1 and B1). These harvesting works were extended to the river and several trees from the buffer area were cut down (red crosses).

Such work in the immediate vicinity of the channel network can be observed at PAU between 1997 and 2002 and 2004 and 2008; at JUN between 2002 and 2004; at CV between 1956 and 1992, and at PIN between 1997 and 2002 and 2004 and 2008. The most significant change in forest cover occurs in PIN between 1997 and 2002, when a large clearance becomes apparent next to the central segment of the study reach including the 10-m buffer on either side of the river (Fig. 7).

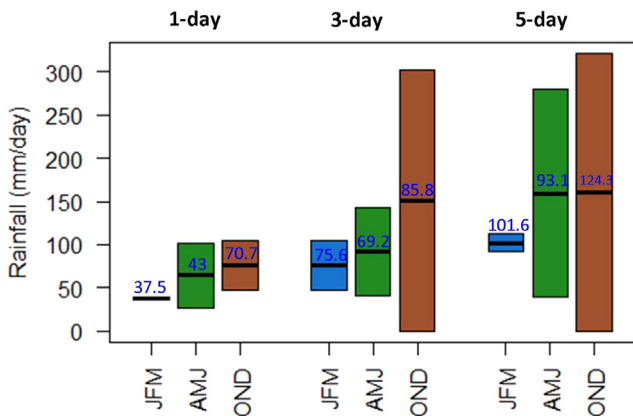
**Fig. 8.** 1-day, 3-day and 5-day average rainfall thresholds during reconstructed events and according to season. Values are based on a previous study (Ballesteros-Cánovas et al., 2015a) and the 1-, 3- and 5-day rainfall thresholds which have triggered flash floods are defined here. (JFM: January, February, March; AMJ: April, May, June; OND: October, November, December).

Analyses of the daily precipitation records since 1946 showed that the 1-, 3- and 5-day rainfall thresholds (Fig. 8) were exceeded
