Fractographic ceramic failure analysis using the replica technique

Scherrer, Susanne; Quinn, Janet B.; Quinn, George D.; Wiskott, Anselm

SCHERRER, Susanne et al. Fractographic ceramic failure analysis using the replica technique. In: Dental materials, 2007, vol. 23, n° 11, p. 1397–1404. doi: 10.1016/j.dental.2006.12.002

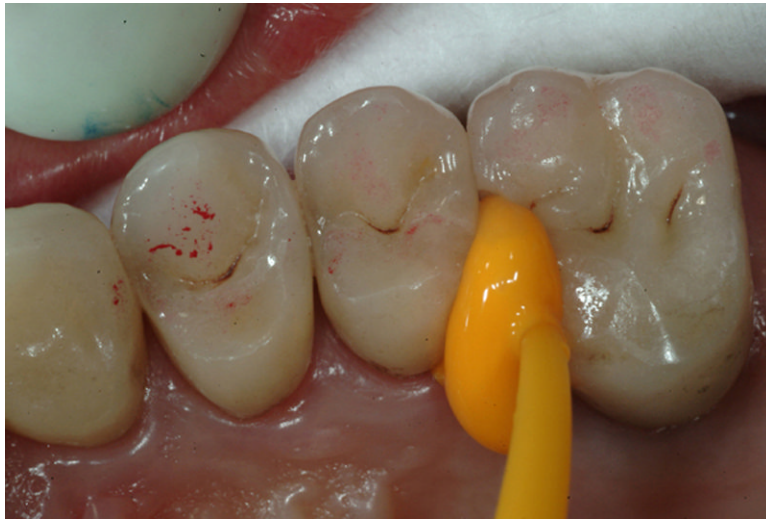
Fig. 2. After having cleaned the fractured surface with an alcohol cotton pellet and air-dried, the silicone impression material is injected first on the fractured zone.

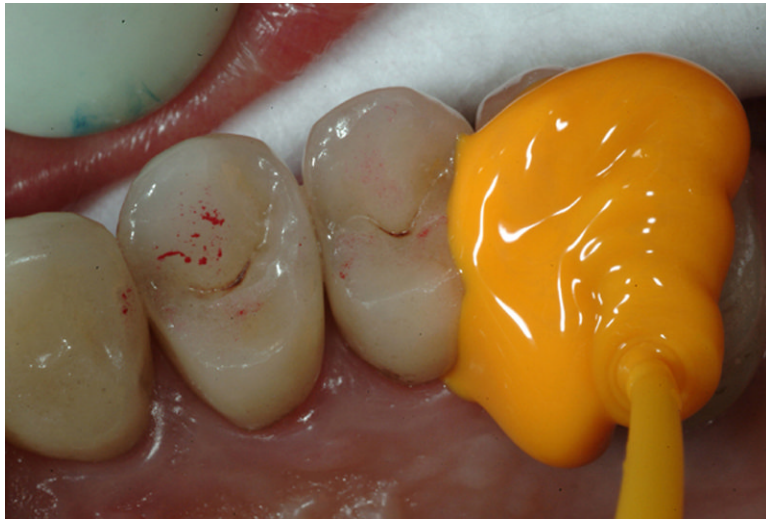
Fig. 3.
The silicone impression material continues to be injected over the occlusal surface

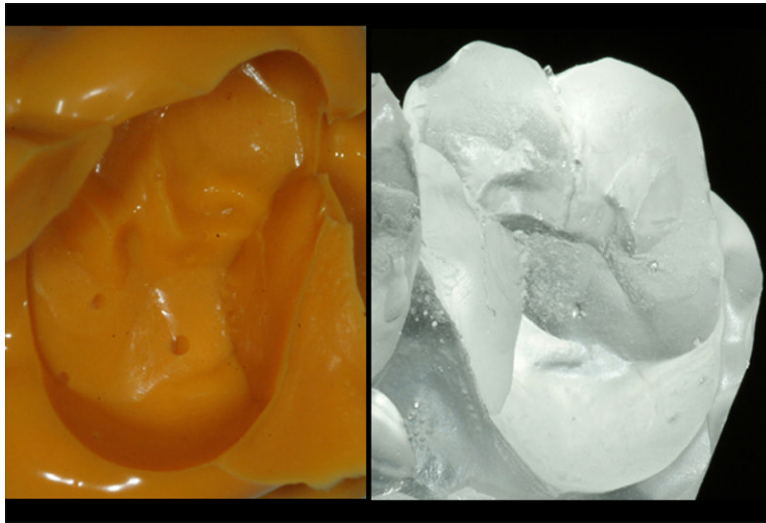
The resin replica (Fig.4) of the failed Procera AllCeram crown was sputter-coated with gold and inspected under SEM magnification. Figure 5a shows the crown from an occlusal view at low power (10x). Major erosive wear is apparent on all four cusps, usually a sign of abnormal parafunction habits (bruxism). The zone delineated by the frame looks similar to the compression curl often seen in bend bars. Such curved surfaces generally arise from mixed mode loading (tension, shear, torsion), and are found to be typical of final crack break-through in dental crowns. Higher magnifications within the frame (Figs.5b,c) near the interproximal mesial margin show hackle and wake hackle indicating the direction of crack propagation towards the margin.

Fig. 4.
a,b: The impression is poured with epoxy resin reproducing the fractured crown.
