Fractographic ceramic failure analysis using the replica technique

Susanne S. Scherrer^a, Janet B. Quinn^b, George D. Quinn^c, and H. W. Anselm Wiskott^a

Objectives—To demonstrate the effectiveness of in vivo replicas of fractured ceramic surfaces for descriptive fractography as applied to the analysis of clinical failures.

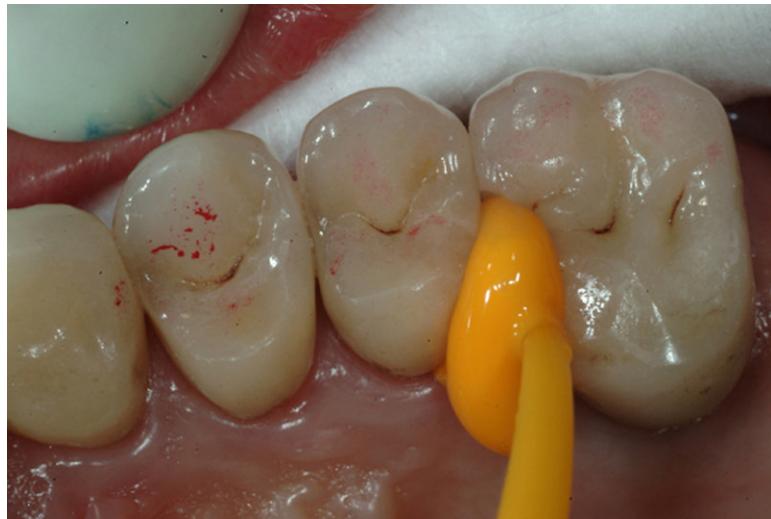
Fig. 1.

Fracture of the veneering porcelain (AllCeram) of an upper left Procera alumina molar after 4.2 years of intra-oral function
