Occult fractures of the scaphoid: the role of ultrasonography in the emergency department

PLATON, Alexandra et al. Occult fractures of the scaphoid: the role of ultrasonography in the emergency department. In: Skeletal radiology, 2011, vol. 40, n° 7, p. 869–875. doi: 10.1007/s00256-010-1086-y

Objective To evaluate ultrasonography (US) performed by an emergency radiologist in patients with clinical suspicion of scaphoid fracture and normal radiographs.

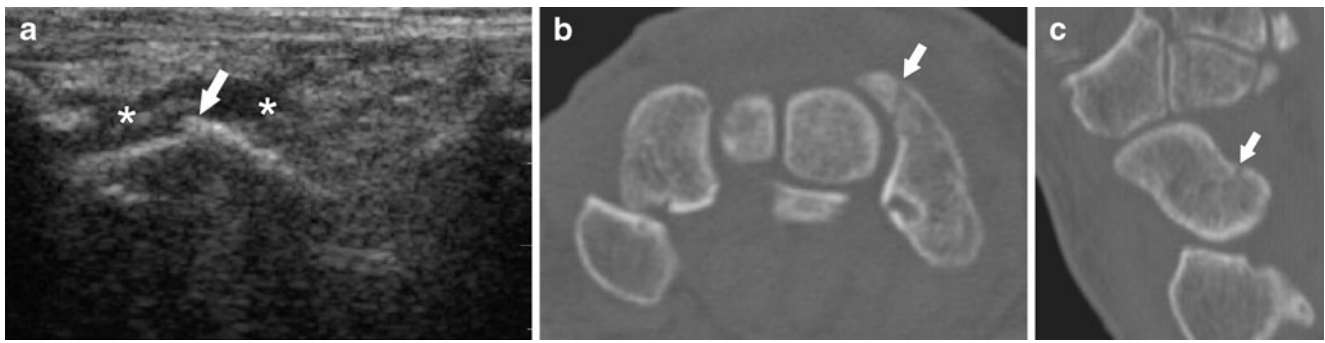
Fig. 1 A 36-year-old man admitted after wrist trauma, with positive clinical signs for scaphoid fracture and normal radiographs. **a** US of the scaphoid in the longitudinal plane shows cortical discontinuity (arrow), along with radio-carpal effusion and surrounding hematoma

(asterisk), suggestive of scaphoid fracture. **b** Axial CT image depicts the fracture as a radiolucent line (arrow), traversing the scaphoid. **c** Sagittal-oblique multiplanar reformation CT image demonstrates the proximal location of the scaphoid fracture (arrow)

All patients belonging to group 1 (fractures with high potential of complications) had sonographic signs associated with scaphoid fractures. Indeed, radio-scaphoid effusion was present in all eight patients of group 1; three of them also had associated STT effusion; no patient had an isolated STT effusion. Associated cortical interruption of the scaphoid bone was described in six of the eight patients (Fig. 1).

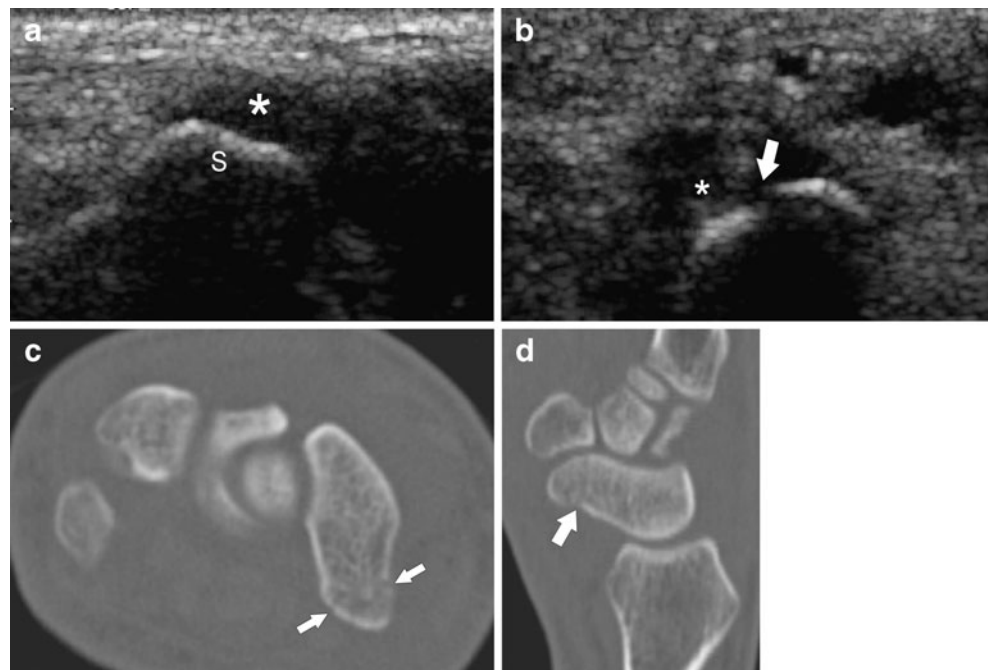
Fig. 2 A 27-year-old woman admitted after wrist trauma, with positive clinical signs for scaphoid fracture and normal radiographs. US of the scaphoid (S) in **a** longitudinal and **b** transverse plane shows a hypoechoic fluid collection (asterisk) anterior to the scaphoid, along with cortical discontinuity (arrow) of the bone, compatible with a fracture. Axial CT image in **c** and sagittal-oblique multiplanar reformation CT in **d** demonstrate the fracture as a radiolucent line (arrows) involving the distal pole of the scaphoid

In group 2 (fractures with low potential of complications), US examination showed suggestive signs of scaphoid fracture in 4 of the 5 patients (Fig. 2). Radio-scaphoid or scapho-trapezoid effusion was reported in the 4 patients; three of them also had cortical discontinuity of the scaphoid bone. In the remaining patient, US did not show any signs suggestive of the diagnosis: this patient had a CT proven fracture of the scaphoid tubercle.

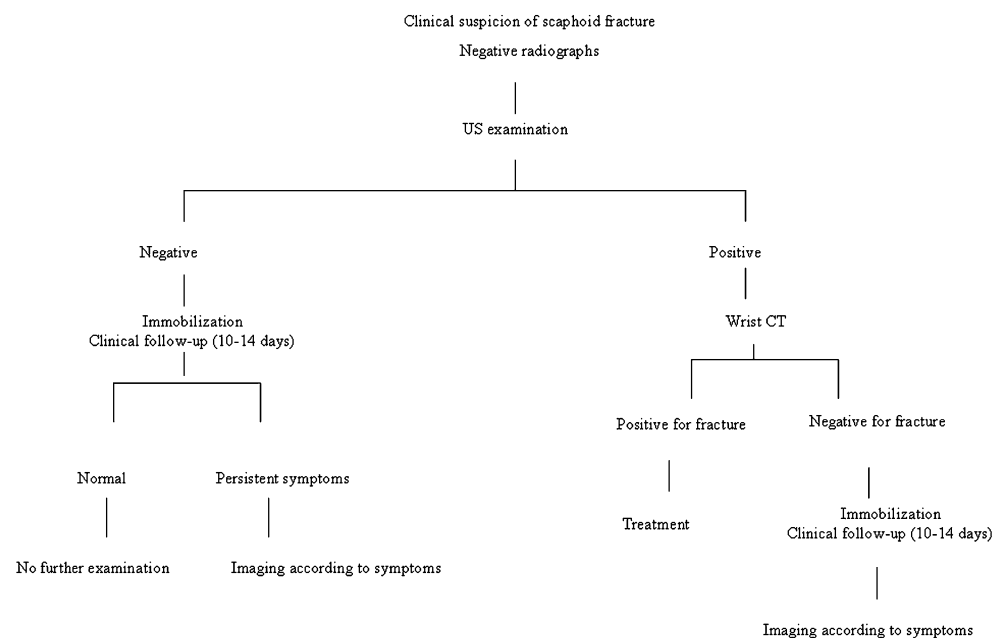
Fig. 3 Suggested algorithm integrating US in the diagnostic work-up of patients with clinically suspected scaphoid fracture and negative radiographs

scaphoid did not require operator-specific skills or training in order to recognize typical signs associated with fracture of the scaphoid. Therefore, US could be integrated in a clinical and radiological algorithm (Fig. 3) for the work-up of patients with clinically suspected scaphoid fracture. When an occult radiographic fracture is suspected based on US findings, the diagnostic strategy and the treatment can rapidly be initiated, decreasing thus the risk for potential delayed complications. In case of negative findings on conventional radiographs, scaphoid US could act as a bridge, orientating the patients toward second-line imaging methods.
