Gully evolution and geomorphic adjustments of badlands to reforestation

SCIENTIFIC REPORTS

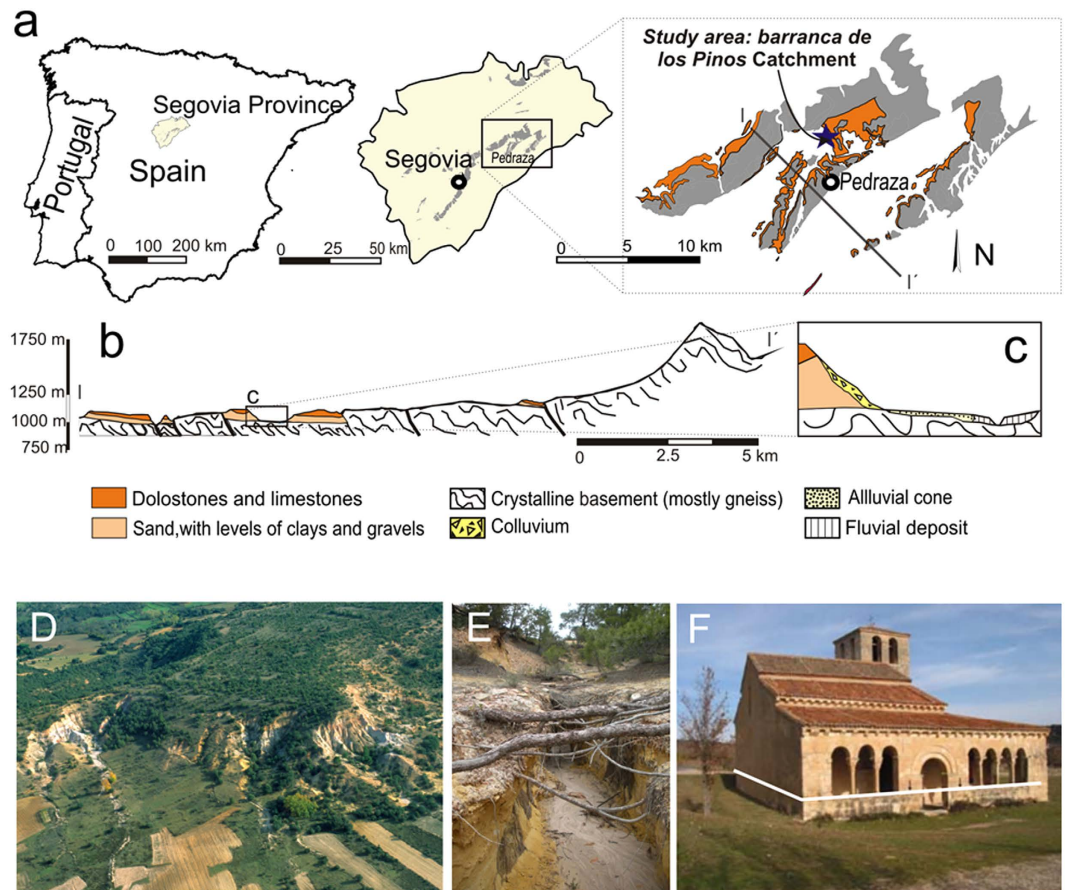
Figure 1. Location of the study area in a geographical (a) and in a geological context (b). (c) The crystalline basement occurs beneath alluvium in the valley bottom, and shows no evidence of re-adjustment due to changes in base level. (d) Aerial view of the studied gullies. (e) Exposed roots in the channel analyzed in this paper. (f) Example of recent (historic) geomorphic activity in the study area. The white line represents the level to which this medieval church was buried, due to continued issuance of sediments from an alluvial cone fed by gullies developed on silica sand slopes. Maps have been created using ArcGIS 10.1 (www.esri.com) and CorelDrawX7 (www.coreldraw.com).

The badland area is located in the Spanish Central System, Province of Segovia (41° 9' 30''N; 3° 48' 30'' W) at an elevation of 1065 m (Fig. 1). Analyses were performed in a representative badland with a gully system, 1.32 ha in size and with slopes gradients >30% on more than one-third of the site. The area is characterized by a set of gullies developed on sand slopes which are interpreted to be the result of geomorphic evolution of former quarries. The site is underlain by Upper Cretaceous marine (limestone and dolostone) and fluvial sediments (gravelly clayey and silica sand). These sediments were deposited on a basement of erosion-resistant Proterozoic and Paleozoic metamorphic and igneous rocks of the Hercynian massif, which outcrop in the Cega River along the main valley bottom of the area, and which promote long-term stability of the channel profile. The region is characterized by temperate dry and warm summer (Csb type), with an average annual temperature of 11.4°C and average annual precipitation of 680 mm (range: 443–992 mm), generally concentrated during winter-early spring months, with maximum daily intensity of 120 mm recorded at the study site in 1982¹⁸. From May 2007 to December 2011, a rain gauge station was installed in the gully, which recorded heavy rainfalls in September 2008, with a maximum daily rainfall of 69.4 mm and a maximum 30-min intensity of 72.4 mm h⁻¹. Since the mid-twentieth century, the area experienced general abandonment of rural activities and mining (i.e., reduced extraction of sand in the gullies), which together with reforestation activities have favored forest recovery at the site (see Supplementary Figs S1 and S2).

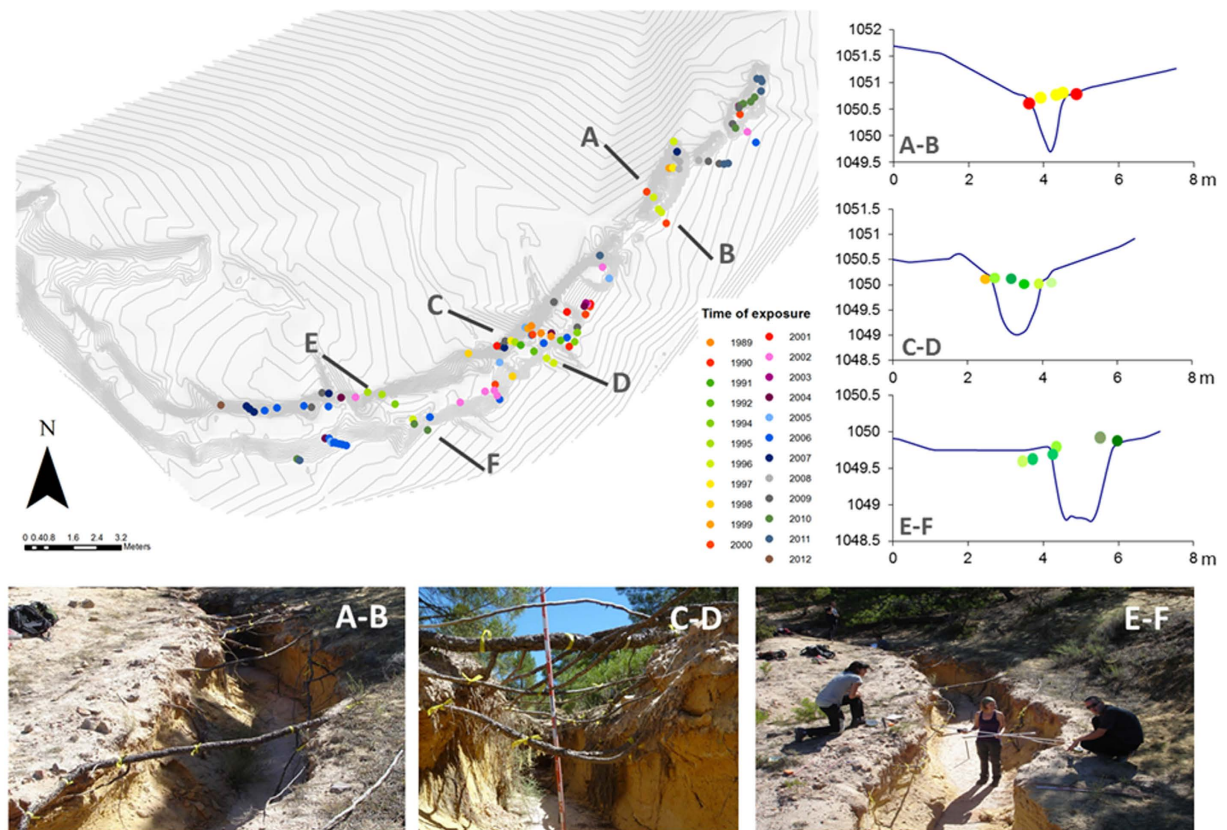
Figure 2. Distribution of the exposed roots analyzed along the channel, as well as three examples of the evolution of different profiles characterized by exposed roots. Map has been created using ArcGIS 10.1 (www.esri.com).

Multi-decadal erosion rate reconstruction. Exposed roots have allowed quantification of erosion processes within the badland with annual resolution over recent decades^{25,26}. Average estimated sheet erosion in three homogenous response units (HRU) was $6.7 \pm 3.8 \text{ mm yr}^{-1}$, with values ranging between 1.6 and 18.7 mm yr^{-1}

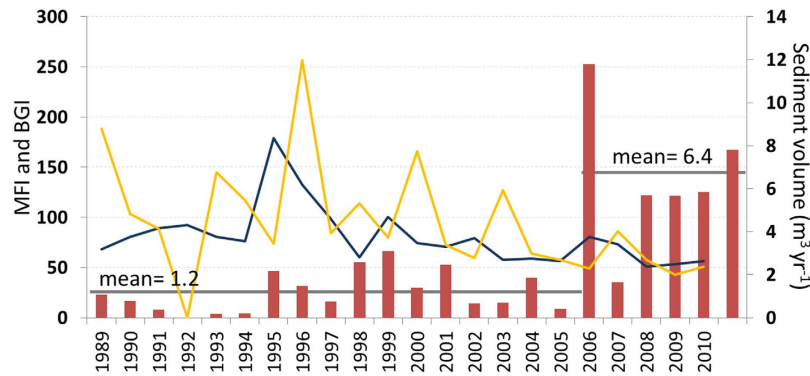
Figure 3. Estimated annual volume (m^3) of sediment eroded for the period 1990–2012 (red bars), as well as the obtained Modified Fournier index (MFI: blue line) and the Bagnouls-Gaussen index (BGI \times -I: orange line). Sediment yield data show a clear change in the trend after 2007, but are not correlated with high IF values.

The total eroded volume for the period 1989–2012 was computed to be 58.5 m^3 . From the channel reconstruction, the greatest erosion episode took place in 2007, when $\sim 11.7 \text{ m}^3$ of sand was mobilized in the system. The reconstruction also reveals a change in erosion rates after 2007. That is, the period 1989–2006 shows a mean erosion volume of $1.2 \text{ m}^3 \text{ yr}^{-1}$, but has since become more than five times larger ($6.4 \text{ m}^3 \text{ yr}^{-1}$) (Fig. 3). These findings point to an intense, recent gully retreat (above the median retreat observed worldwide- 0.89 m yr^{-130}), although the catchment area that is delivering runoff and material to the channel is relatively small ($\sim 1.3 \text{ ha}$).
