## Effects of fiber-glass-reinforced composite restorations on fracture resistance and failure mode of endodontically treated molars

NICOLA, Scotti et al. Effects of fiber-glass-reinforced composite restorations on fracture resistance and failure mode of endodontically treated molars. In: Journal of dentistry, 2016, vol. 53, p. 82–87. doi: 10.1016/j.jdent.2016.08.001

**Objectives:** The study evaluated the fracture resistance and fracture patterns of endodontically treated mandibular first molars restored with glass-fiber-reinforced direct composite restorations.

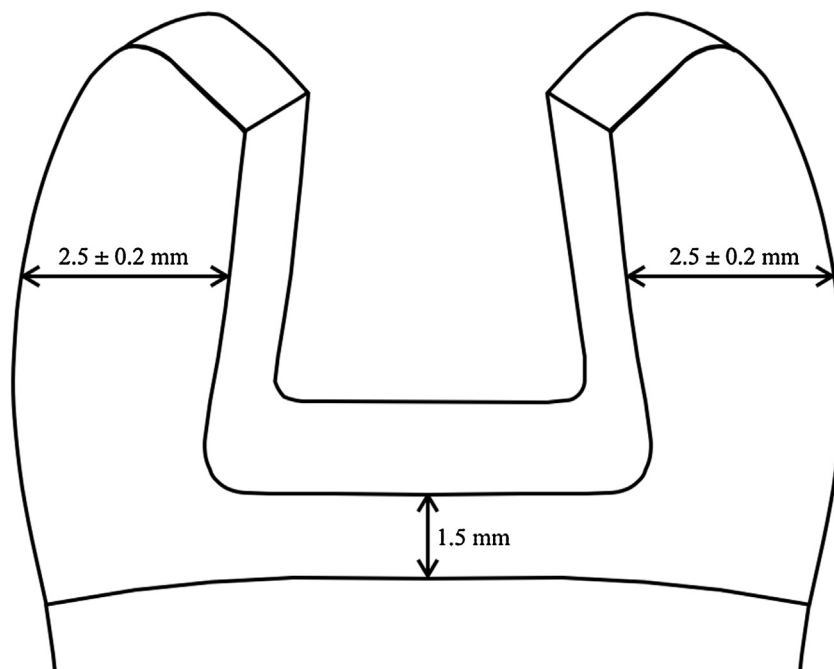
Fig. 1. Schematic representation of the cavity preparation used in this experiment.

After 48 h in distilled water, standardized class II mesio-occluso-distal (MOD) cavities were prepared by the same experienced operator in all specimens except the positive control group. For cavity preparation, cylindrical diamond burs (#806314014; Komet, Schaumburg, IL, USA) under copious air-water cooling were used in a high-speed headpiece (Kavo Dental GmbH, Biberach, Germany). The residual thickness of buccal and lingual cusps at the height of the contour was  $2.5 \pm 0.2$  mm in all specimens, with the medial and distal cervical margin located

1.5 mm coronal to the CEJ (Fig. 1). After finishing the preparation, all internal edges were smoothed and rounded.

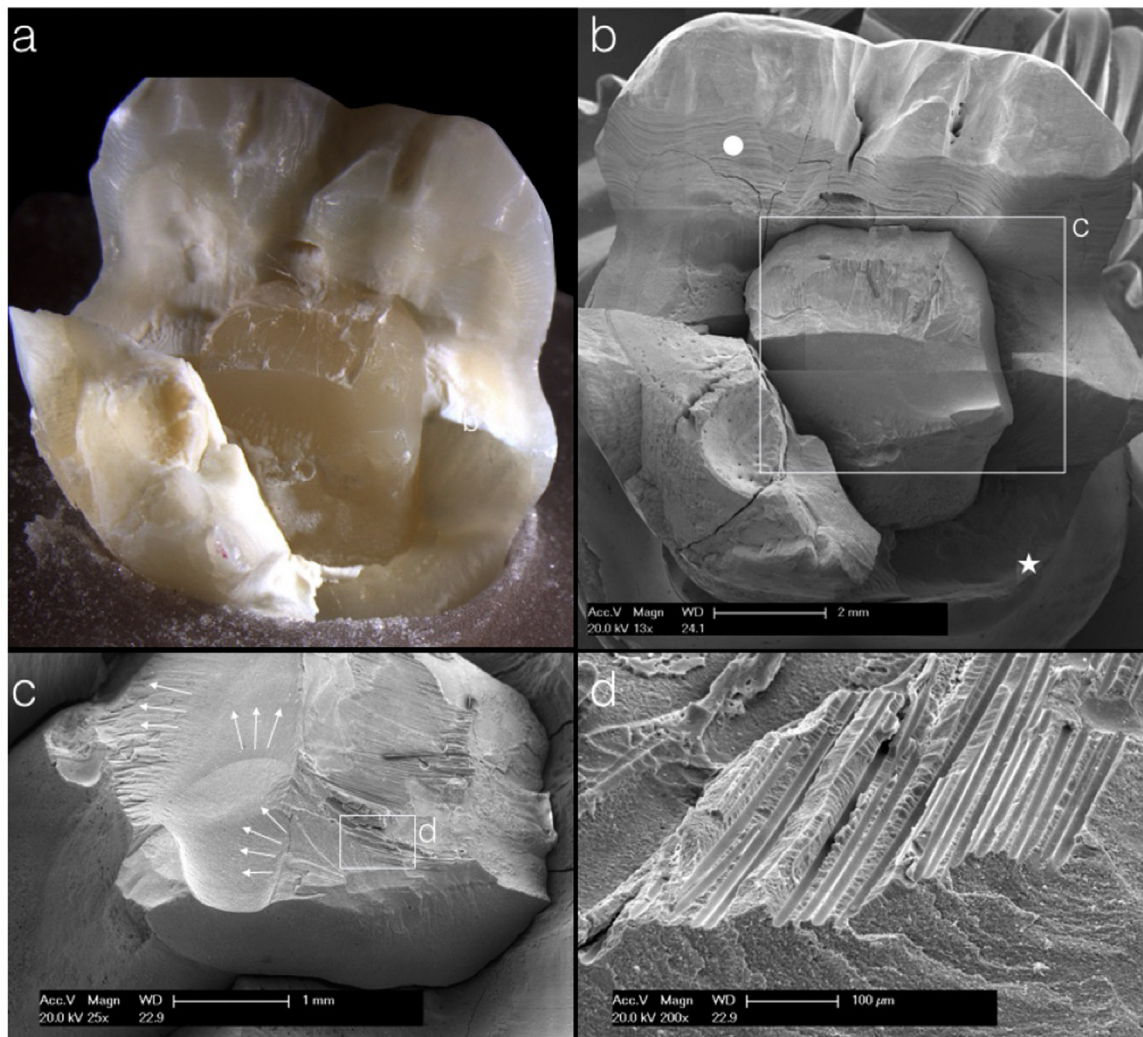
**Fig. 2.** A fractured specimen from group 6. (a) Stereomicroscope image of the pattern of the fracture. (b) Scanning electron microscope (SEM) image showing the mixed fracture: marks produced by the diamond bur (white circle) were still visible on the internal part of the palatal wall. The fracture ended at the level of the palatal root, where it produced a “compression curl” (white star). The white rectangle c in (b) represents (c). (c) Hackle lines (white arrows) indicate the presence of a partial cohesive fracture of the build-up, and show the direction of the crack propagation. The white rectangle d in (c) represents (d). (d) The layer of glass fiber, which left an impression (white star) on the resin composite build-up, caused a partial interruption of the propagation of the fracture. However, this was not enough to completely stop the crack.

marked on the root. Some mixed secondary fractures (adhesive-cohesive) occurred, predominantly in the internal part of the restorations or on the occlusal surface. In G6, the layer of fibers, disposed with a buccal-palatal orientation, induced a partial deflection of the fracture, although they were not able to stop the crack propagation (Fig. 2).

To evaluate the fracture pattern, a combined stereo and scanning electron microscopy technique was used [31]. The stereomicroscope showed the whole surface of the fractured specimens. SEM images gave information on fractographic markers, such as hackle lines, arrest lines, and compression curl, which are indicators of the crack propagation direction. A fractographic analysis of the pattern of a fragment provides important information when a cohesive fracture occurs. In adhesive fractures, most of the features left by the crack, such as the origin, the “mirror” and the “hackle,” are not visible. However, the end of the event was indicated by the presence of the “compression curl,” left on the cracked roots of the specimens, meaning that the origin was in an upper region. Some secondary cohesive fractures were also recognizable. In G6, the denuded ranks of fibers left a mark on the surface of the build-up after their debonding (Fig. 2). This indicates that the main front of the fracture was partially deviated once it touched the layer of fibers, following their horizontal direction. However, this effect was not sufficient to avoid a catastrophic break: the charged wall always deflected until fracture.
