The 2020 glacial lake outburst flood at Jinwuco, Tibet: causes, impacts, and implications for hazard and risk assessment

Guoxiong Zheng^{1,2,3}, Martin Mergili^{4,5}, Adam Emmer⁴, Simon Allen^{2,6}, Anming Bao^{1,7}, Hao Guo⁸, and Markus Stoffel^{2,9,10}

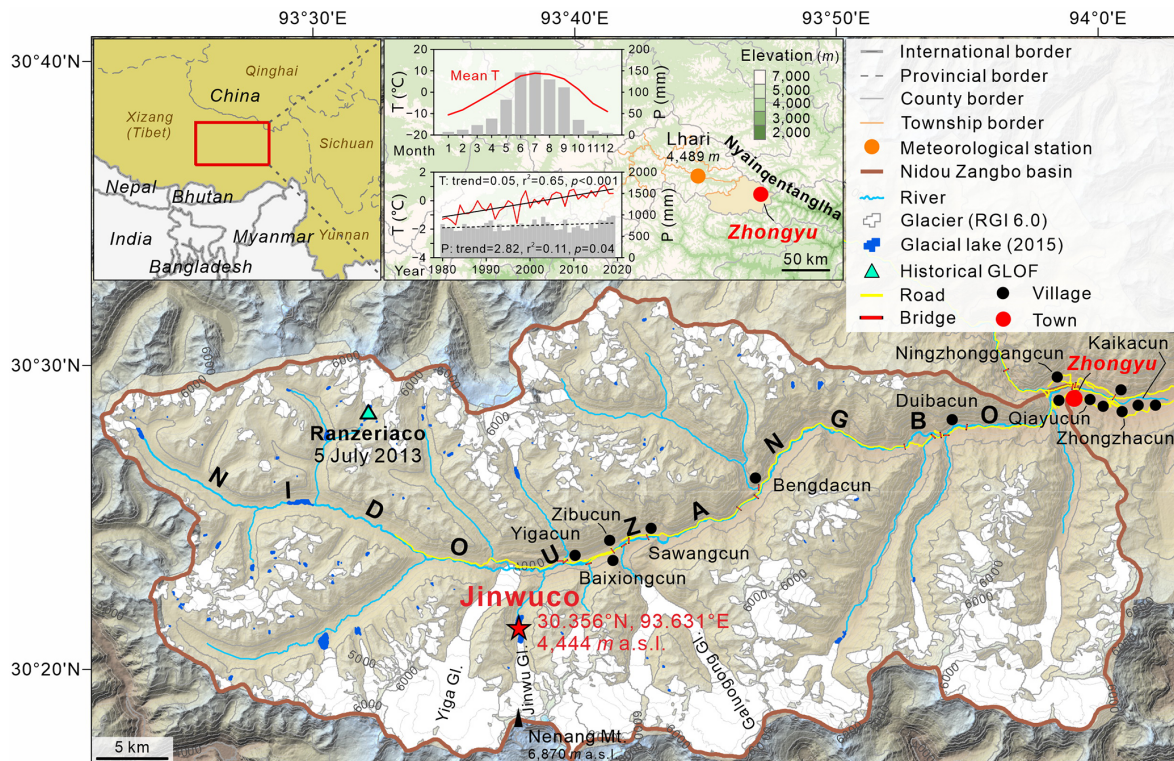
Figure 1. Location of Jinwucuo and surrounding geographic features, including terrain, rivers, glaciers, glacial lakes, settlements, and major infrastructures (roads and bridges) downstream. The climate statistics in the upper middle panel are based on the Lhari weather station, approx. 50 km away from Jinwucuo, 1980–2019. The topographic base map is based on the DEM generated from Ziyuan-3 stereoscopic pairs. The borders and location of the villages are from © Baidu Maps.

The study area is located at the Nidou Zangbo (“Zangbo” refers to rivers in Tibetan) watershed in the eastern Nyainqentanglha, Tibet Autonomous Region, China (Fig. 1). The Nidou Zangbo originates from the eastern foothills of the Luola Mountains near the north of Zhongyu township in Lhari County with a length of 68 km (Liu, 2014) and is the right tributary of Yi’ong Zangbo. The watershed covers an area of 1267 km² with an elevation difference of 3715 m. The topography of the watershed is high in the west and low in the east, with an average elevation of > 5000 m. Most of the peaks in the watershed reach more than 6000 m, with the highest peak, Nenang Peak, at 6870 m. The glacial and paraglacial landscapes are highly developed in the watershed, with a total of 294 glaciers (≥ 0.05 km² around 2005) covering a combined area of 396 km² (RGI Consortium, 2017). There are 96 glacial lakes (≥ 900 m² around 2015) distributed in the watershed with a total area of 3.2 km² and an average area of 0.03 km² (Zheng et al., 2021), of which the majority are moraine-dammed lakes. The watershed is part of the sub-humid monsoon climate zone of the plateau with cold winters and cool summers (M. Sun et al., 2014). The average annual temperature recorded from the Lhari weather station during 1980–2019 is -0.2 °C with an average lowest temperature of -10.6 °C in January and an average highest temperature of 8.9 °C in July (Fig. 1). The average annual total precipitation is 753 mm, and about 80 % is concentrated from May to September (Fig. 1), largely controlled by the south Asian monsoon (M. Sun et al., 2014).

From the administrative location, the Zhongyu township where Jinwucuo is situated is part of the southeastern Lhari County, 118 km from the county seat. It contains 14 administrative villages in total. Six of them are within the middle and upper reaches of the Nidou Zangbo basin (Fig. 1).

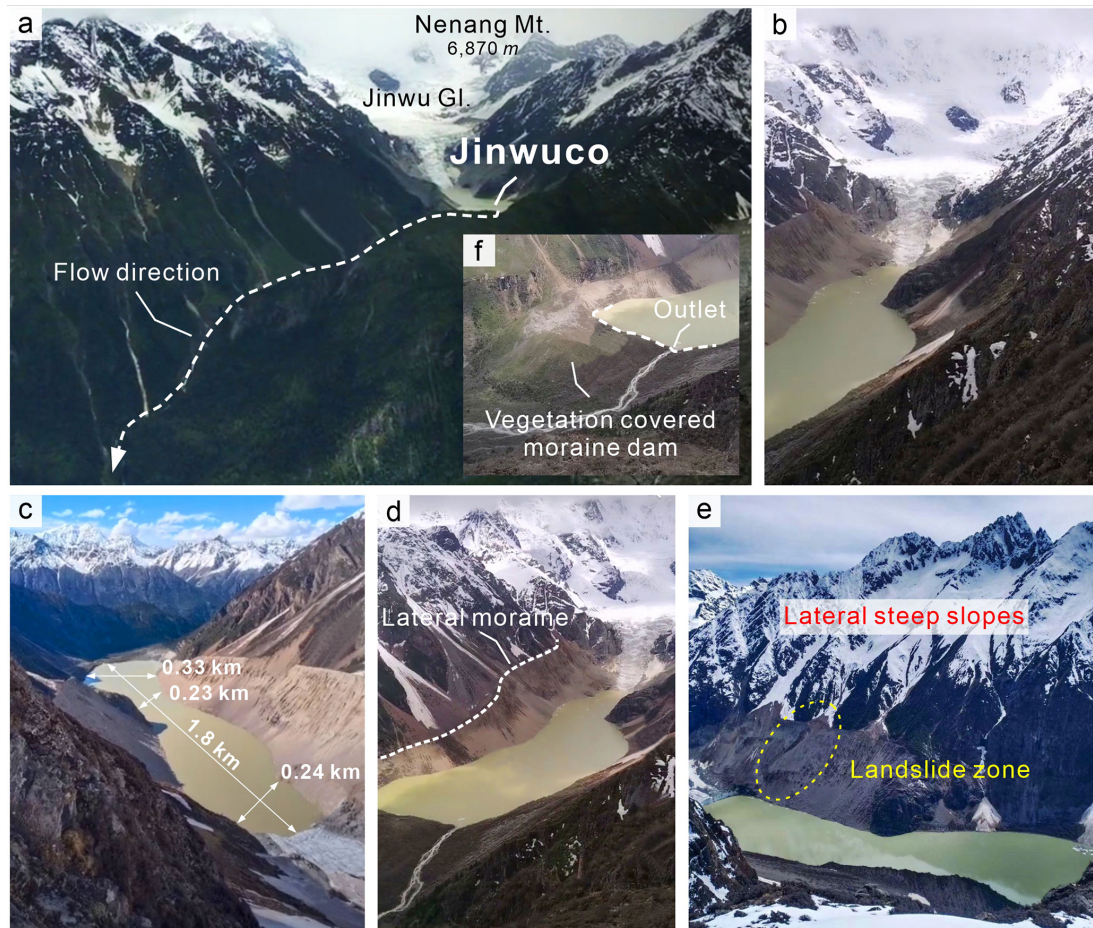
Figure 2. Overview of Jinwuco before the collapse of the dam. (a) An overall view of Jinwuco and surroundings taken from the opposite valley on 19 June 2020. (b) Crevassed hanging glacier ice terminated in Jinwuco, taken from downstream to upstream of the lake on 11 June 2020. (c) Morphological parameters of Jinwuco; photo taken from upstream to downstream of the lake on 15 June 2020. (d) Lateral moraine and steep mountain slopes from west to east (11 June 2020) and (e) from east to west (30 May 2020). (f) Vegetation-covered moraine dam and the position of the outlet (11 June 2020). Photos: Qiangba Quying (used with permission).

Jinwuco (also known as Jiwengco, 30.356° N, 93.631° E) is a proglacial moraine-dammed lake (Fig. 2) which is also the largest glacial lake within the Nidou Zangbo basin (Zheng et al., 2021). It is situated at the terminal of the Jinwu Glacier that covers an area of 7.9 km², and the lake is in contact with the steep ice tongue. The ice tongue enters the lake

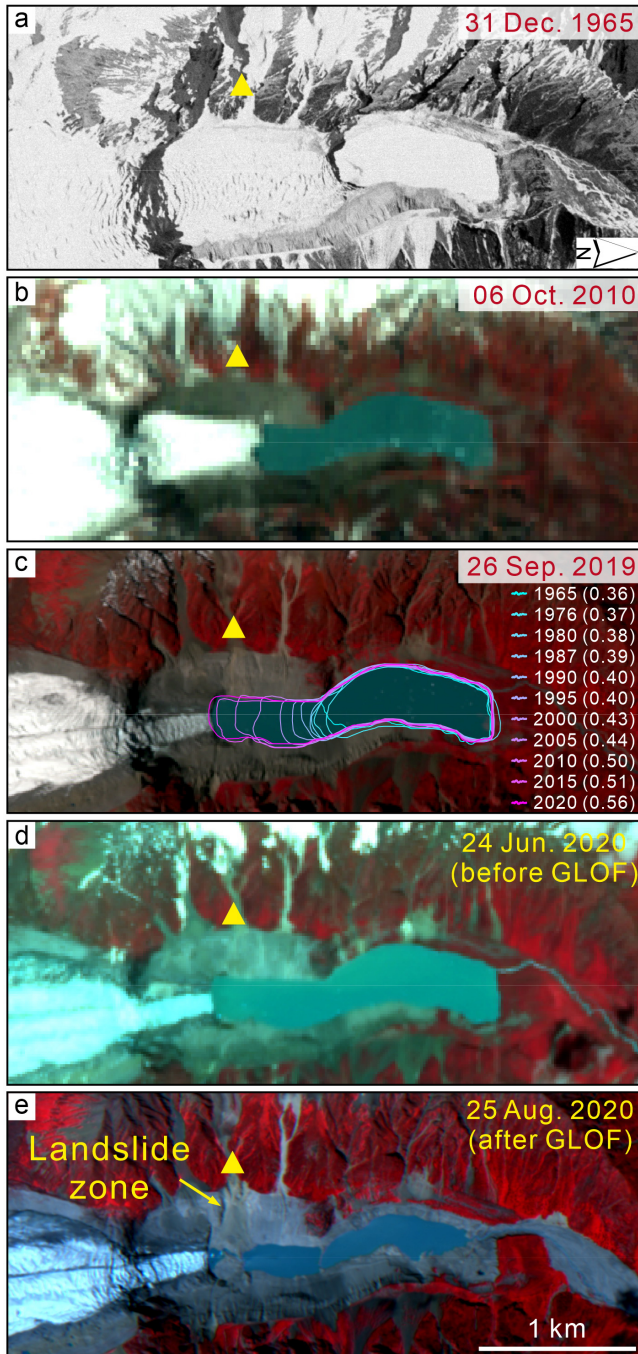
Figure 3. Satellite images documenting the evolution of Jinwuco during 1965–2020 and the location of the debris landslide. The lake area in parentheses of panel (c) is given in square kilometers. The backgrounds are from Corona KH-4A, Landsat-5 TM, Sentinel-2A, Gaofen-1, and Ziyuan-3, respectively.

Historical satellite images reveal that Jinwuco has undergone significant areal expansion since 1965 (Fig. 3). In 1965, its surface area was $0.36 \pm 0.003 \text{ km}^2$. By 10 May 2020, the lake area has increased to $0.56 \pm 0.02 \text{ km}^2$, showing an increase of approx. 56 % relative to 1965 (Fig. 4). Overall, the surface area of Jinwuco shows a non-linear growth trend from 1965 to 2020 – with an accelerated growth rate observed from 1995. Importantly, the rear part of the lake, where the landslide deposited, is shown to have developed since 2010 (Fig. 3). After the GLOF event on 26 June 2020, the lake area is reduced by approx. 54 % to $0.26 \pm 0.01 \text{ km}^2$ (Fig. 4).

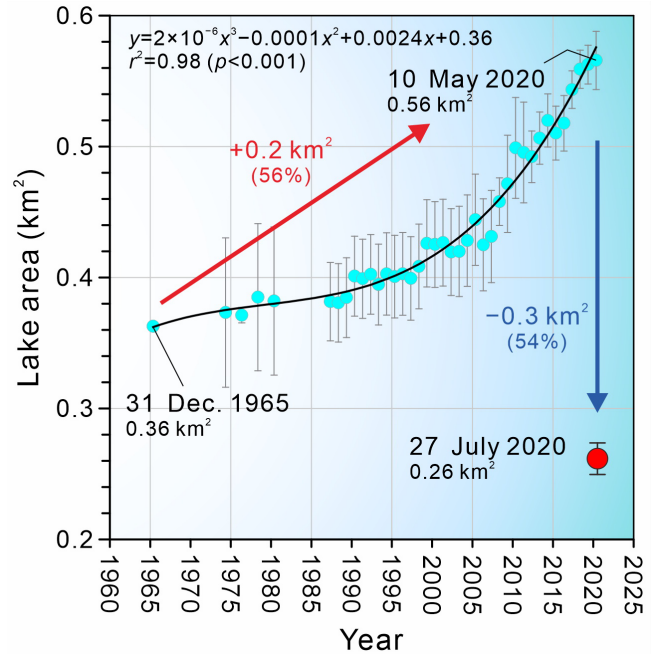
Figure 4. Inter-annual dynamics of Jinwuco during 1965–2020 (prior to the GLOF), and the abrupt decrease in lake area after the GLOF.

1. *Lake.* The pre-event lake area was approx. $560\,000 \text{ m}^2$ (Fig. 4), with a maximum width of ca. 360 m. A lake volume of 13.9 million cubic meters is reconstructed (Sect. 4.4), corresponding to a maximum lake depth of 54 m. The pre-event lake level is set to 4444 m, whereas the post-event lake level is set to 4424 m, resulting in a drop of 20 m during the event. In the frontal portion of Jinwuco, some discrepancies exist between the post-event lake extent derived from the DEM and the satellite image (Fig. 5): this mismatch most likely indicates inaccuracies of the DEM.
2. *Landslide.* The Gaofen-1 imagery of 24 June reveals that the landslide had not yet happened until this point in time. Assuming that the landslide occurred before the GLOF, we constrain the timing of the landslide to the period 24–26 June 2020. A landslide release volume of

(Bolch et al., 2019) and particularly align to the period of accelerated expansion of Jinwuco (Fig. 4). While there are few studies directly linking the response of individual or even regional glacial changes to anthropogenic warming, it is considered extremely likely that anthropogenic emissions have been the primary driver of the cumulative glacier mass loss observed globally since 1850, with a central estimate of up to 100 % (Roe et al., 2021). Physically there is no obvious argument to suggest glaciers in this region of Tibet have responded anomalously from what has been established globally. If we therefore consider that anthropogenic warming has at least played a major (if not dominant) role in the retreat of Jinwu Glacier and associated lake growth, the discussion turns to how this retreat could have increased the likelihood and/or magnitude of the 26 June GLOF event. It is well established that paraglacial landscapes are characterized by anomalously high rates of erosion and mass movements compared to other environments, with debris flows, slides, and avalanches being the primary mode of failure (McCull, 2012; Knight and Harrison, 2014). The reworking and modification of paraglacial landscapes occurs rapidly following glacial retreat, with stabilization of proximal slopes occurring within a few decades to centuries (Ballantyne, 2002). Over this time, paraglacial slopes remain particularly susceptible to heavy rainfall or melt processes (Blair, 1994; Evans and Clague, 1994; Chiarle et al., 2007), and when mass movements of rock or debris enter adjacent lakes, GLOFs

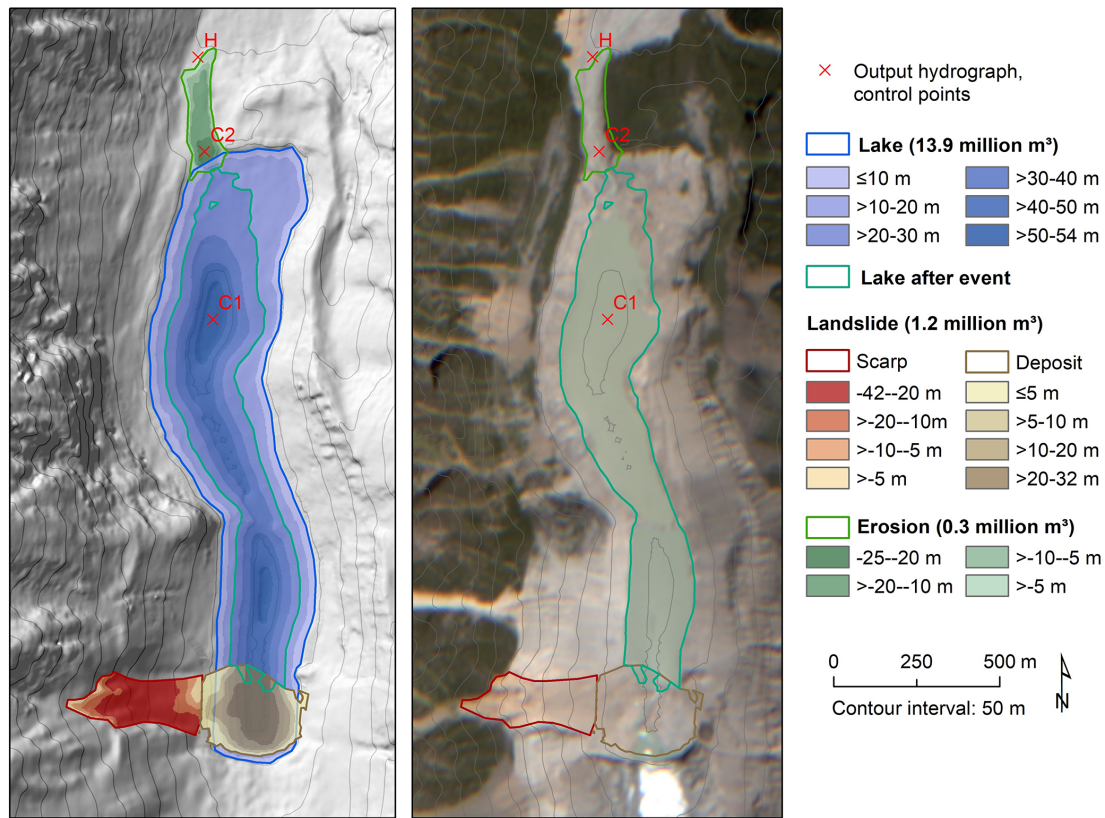
Figure 5. Reconstruction of the lake depth, landslide, and breach of the moraine dam. The base map is a shaded relief map (left) based on the DEM generated from Ziyuan-3 stereoscopic pairs and the Ziyuan-3 satellite scene (right) acquired on 25 August 2020.

The reconstruction of the main features allows for drawing some conclusions about the mechanisms involved in the GLOF process chain and for estimating the mobilized volumes (Figs. 5 and 6).

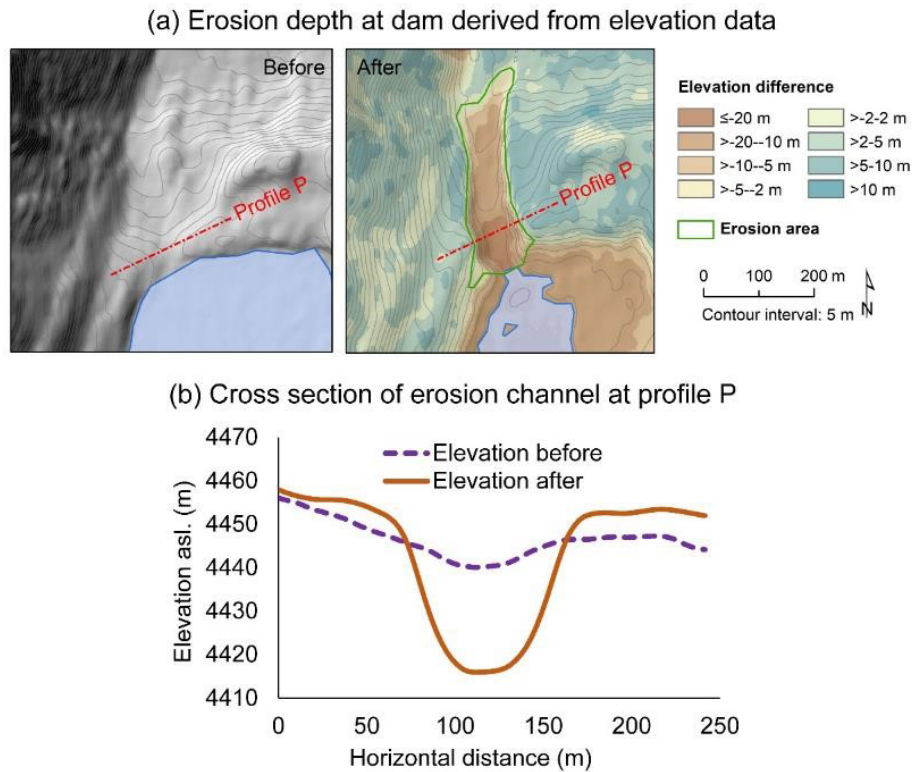
Figure 6. Breach of the moraine dam of Jinwuco. (a) Situation before and after the event of 26 June 2020, with difference in elevation between the DEMs derived before and after the event. (b) Cross section along the profile P (see a) before and after the event. The topographic base map is based on the DEM generated from Ziyuan-3 stereoscopic pairs.

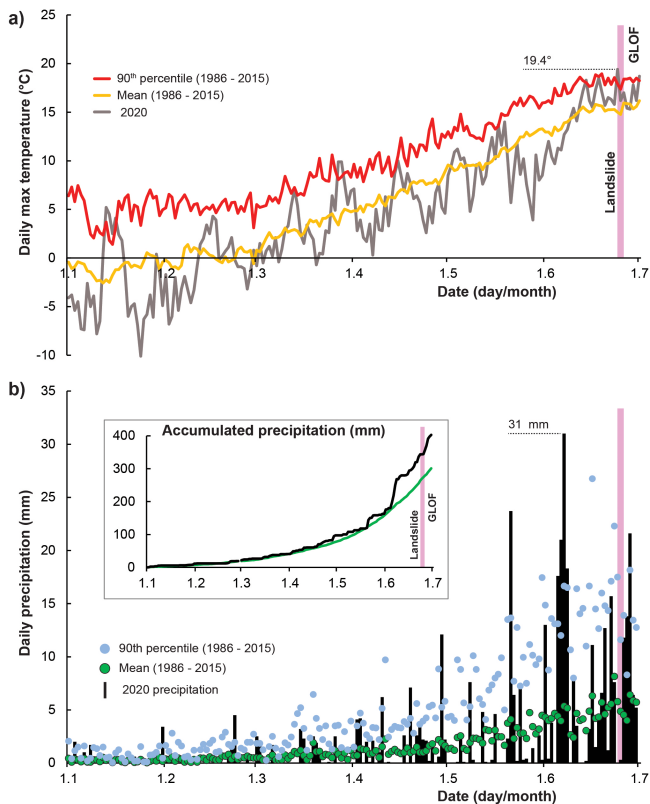
Figure 7. Meteorological conditions from January–June 2020, measured at the Lhari weather station, compared to the longer-term climatology (1986–2015).

We now elaborate on the possible triggers of the landslide. The meteorological conditions in June 2020 (Fig. 7) were characterized by extremely high precipitation in the period from 5–8 June. Further rainfall and snowmelt under unusually warm conditions after 8 June are factors which most likely caused a gradual destabilization of the moraine. The

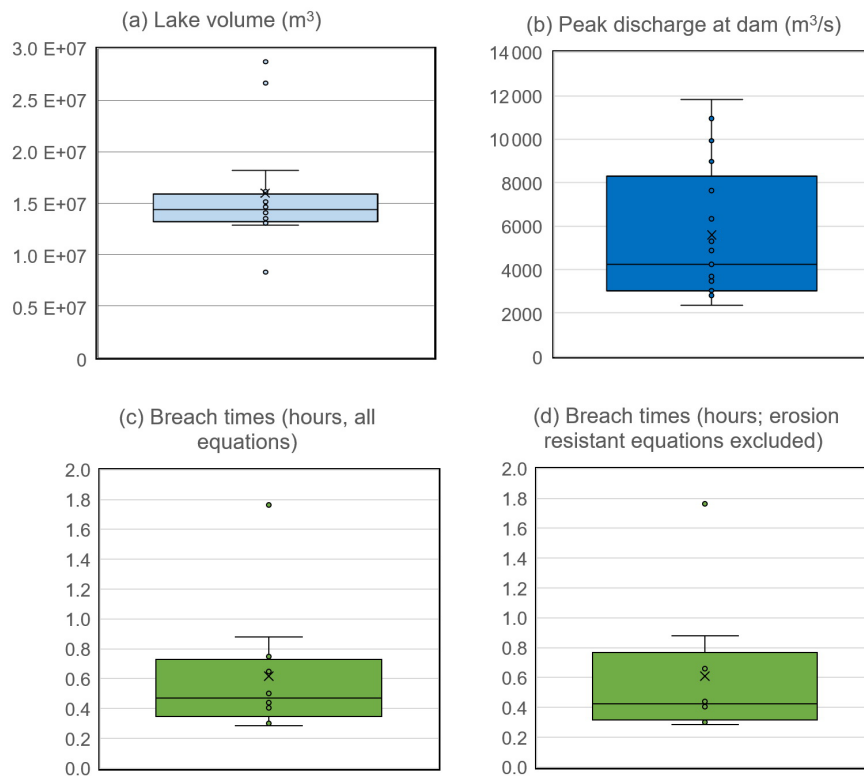
Figure 8. Lake, dam breach, and flood parameters, derived from sets of published empirical relationships. **(a)** Volume of Jinwuco. **(b)** Peak discharge at the dam. **(c)** Breach time, considering all available equations. **(d)** Breach time, considering only those equations derived for easily erodible dams (an assumption we consider likely to hold for the dam of Jinwuco).

The patterns yielded with the simulation of Scenario B (Fig. 9c and d) are similar in general, with the exception of the initial impact wave that is only observed in Scenario A. However, onset of erosion takes more time, so that the breach and associated emptying of the lake are delayed. The tipping point where slight channel erosion turns into a rapid dam breach occurs at approx. 35–39 min after the start of the simulation, depending on the definition. The base level of the erodible material is reached at $t = 62$ min (23–27 min or 0.38–0.45 h after the tipping point – in the lower part of the range indicated in Fig. 8d). The peak discharge of 4600 m³/s

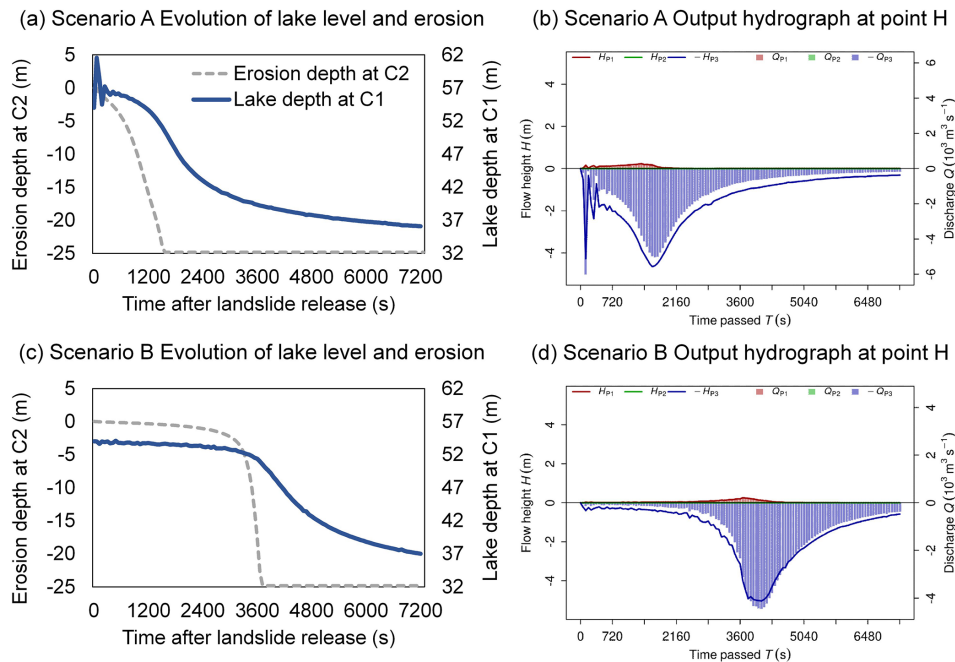
Figure 9. Dam breach as simulated with r.avaflow. **(a)** Scenario A, evolution of lake level and the erosion channel. **(b)** Scenario A, output hydrograph. **(c)** Scenario B, evolution of lake level and the erosion channel. **(d)** Scenario B, output hydrograph. Locations of the points C1, C2, and H are indicated in Figs. 5 and 11. In the output hydrographs, H means flow height, and Q means discharge. The subscript P1 refers to phase 1 (rock), P2 to phase 2 (not existent in this case), and P3 to phase 3 (water). Fluid discharge and flow height are plotted in the negative direction for better readability.

A detailed look at the dam breach (Fig. 9) reveals that the simulation results for both scenarios A and B are in good correspondence with the ranges of peak discharge and breach depth derived through the empirical relationships described in Sect. 4.4 and illustrated in Fig. 8. For Scenario A, at the point C2 (Figs. 5 or 10), depth erosion is completed at $t = 26$ min after landslide release, i.e., 24–25 min (0.41 h) after the impact wave had reached the outlet of the lake, initiating retrogressive erosion. This time span is well within, although in the lower part of, the range revealed in Fig. 8d. After the breach has developed to its full depth, lake drainage continues and asymptotically approaches the level of the eroded gully (Fig. 9a). The peak discharge associated with the landslide-induced impact wave reaches 17 900 m³/s after 100 s (computed at a higher temporal resolution and therefore not visible in Fig. 9b). Afterwards, discharge decreases and then increases again due to retrogressive erosion of the moraine dam. The simulated peak discharge during the retrogressive erosion stage reaches 5200 m³/s at $t = 28$ min, being well within the range indicated in Fig. 8b. With dropping lake level, the simulated discharge slowly decreases to a small residual value after 2 h (Fig. 9b). At all stages, the simulated flow is dominated by water, with a peak of approx. 220 m³/s of solid discharge at $t = 23$ min, when retrogressive erosion is the most intense.

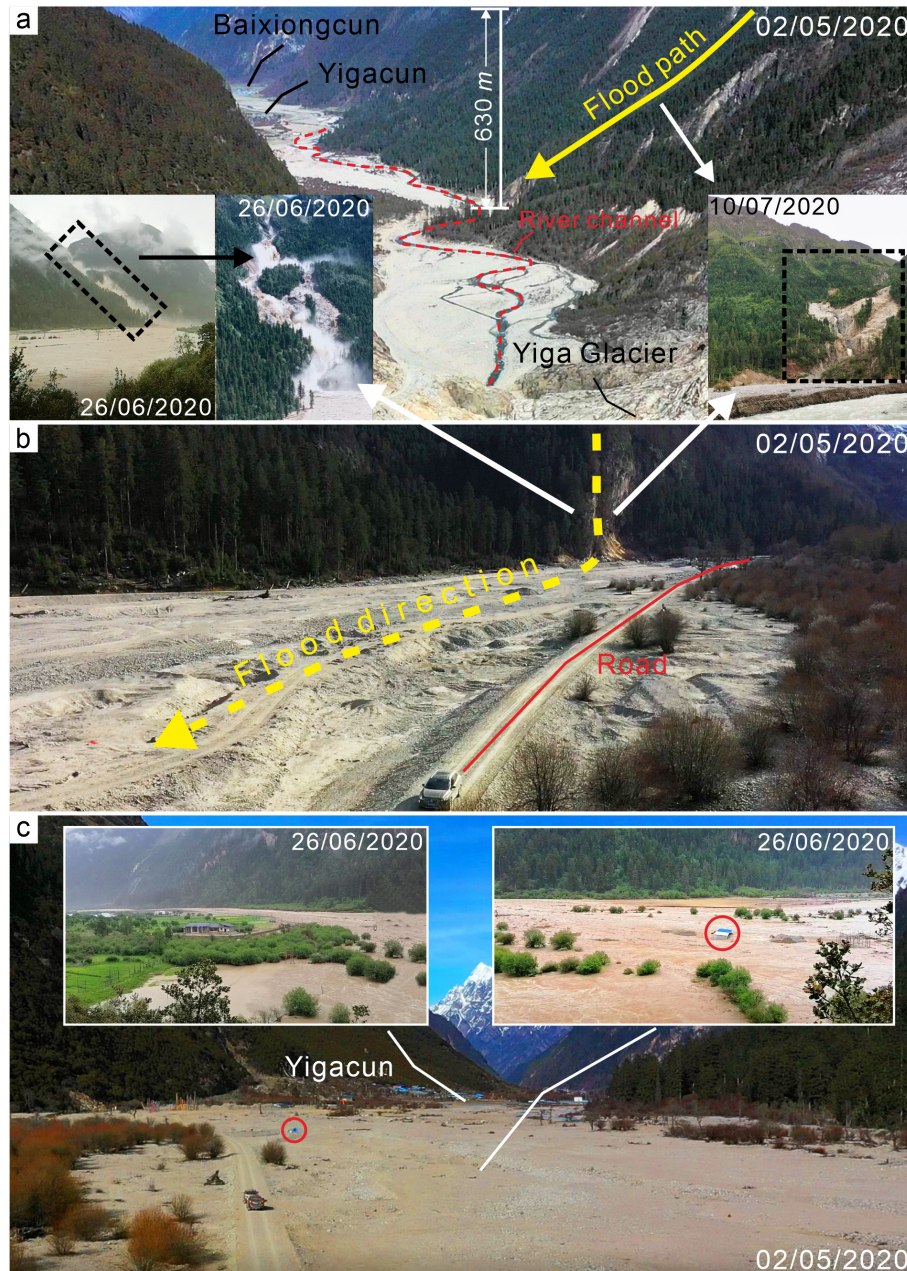
Figure 11. The situations in the valley and river channel below Jinwuco before, during, and after the GLOF. (a) Photo taken from Yiga Glacier looking to Yigacun. Insets showing the situations in the valley during and after the GLOF (photos: Qiangba Quying and Yixi Quzhen). (b) The river channel and road before the GLOF taken from Yigacun looking upstream. The yellow dashed line is the flood flow direction. (c) A view taken from upstream looking to Yigacun. Insets showing the situations in the river channel during the GLOF (photos: Qiangba Quying). Aerial photos from 2 May 2020 were taken by Kejun Liang.

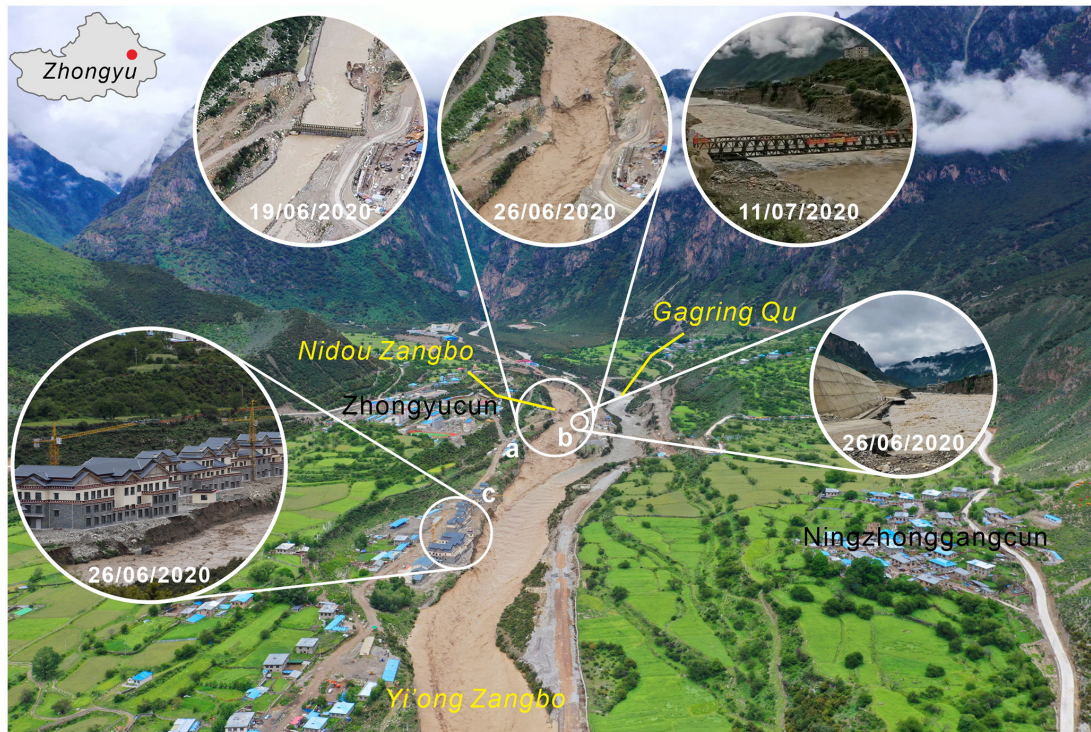
Figure 12. Examples of GLOF damage to downstream infrastructure and buildings at the confluence of Nidou Zangbo and Gagring Qu. Background aerial photo by Heng Li taken on 26 June 2020. (a) Comparison of the bridge connecting Zhongyucun and Ningzhonggangcun before, during (photos: Heng Li), and after the GLOF (rebuilt, photo: Kejun Ma). (b) Destroyed roads (photo: Heng Li). (c) Affected buildings at risk (photo: Heng Li).

caused severe destruction to villages and infrastructure to various degrees on both sides of the downstream river. The destruction consists mainly of damage to buildings, roads, bridges, or farmland, just to name a few (detailed statistics are provided in Table 3). Fortunately, this event did not lead to any fatalities or injuries largely because it took place during the daytime, and the villagers collecting medicinal herbs upstream observed the flood and promptly informed the downstream villages to evacuate. The affected area includes almost all the villages on both sides of the river, especially Baixiongcu and Zibucun. These are also the most affected by the 2013 Ranzeriaco GLOF (Fig. 1; Liu, 2014). The power of the flood is noticeably weakened after its confluence with the Gagrang Qu in the Zhongyucun and hence does not result in much damage to areas further downstream. This flood damaged a major proportion of 43.9 km of roads between Yigacun and Zhongyu township (Fig. 1; Fig. 11), as well as the only steel bridge to the township office (Fig. 12a), which caused certain difficulties for timely emergency rescue operations.
