The 2020 glacial lake outburst flood at Jinwuco, Tibet: causes, impacts, and implications for hazard and risk assessment

Zheng, Guoxiong; Mergili, Martin; Emmer, Adam; Allen, Simon Keith; Bao, Anming; Guo, Hao; Stoffel, Markus

The Cryosphere, 15, 3159–3180, 2021 https://doi.org/10.5194/tc-15-3159-2021 © Author(s) 2021. This work is distributed under the Creative Commons Attribution 4.0 License.

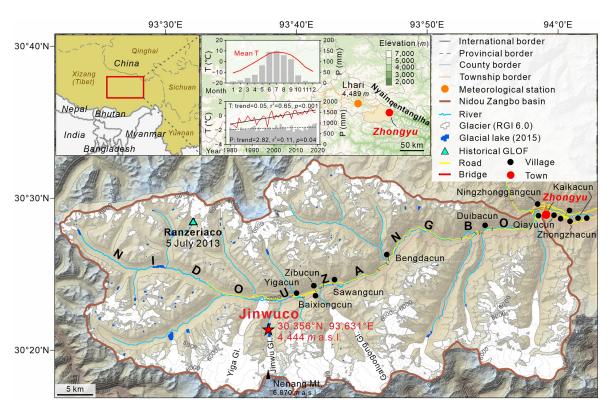
Figure 1. Location of Jinwuco and surrounding geographic features, including terrain, rivers, glaciers, glacial lakes, settlements, and major infrastructures (roads and bridges) downstream. The climate statistics in the upper middle panel are based on the Lhari weather station, approx. 50 km away from Jinwuco, 1980–2019. The topographic base map is based on the DEM generated from Ziyuan-3 stereoscopic pairs. The borders and location of the villages are from © Baidu Maps.

The study area is located at the Nidou Zangbo ("Zangbo" refers to rivers in Tibetan) watershed in the eastern Nyainqentanglha, Tibet Autonomous Region, China (Fig. 1). The Nidou Zangbo originates from the eastern foothills of the Luola Mountains near the north of Zhongyu township in Lhari County with a length of 68 km (Liu, 2014) and is the right tributary of Yi'ong Zangbo. The watershed covers an area of 1267 km² with an elevation difference of 3715 m. The topography of the watershed is high in the west and low in the east, with an average elevation of > 5000 m. Most of the peaks in the watershed reach more than 6000 m, with the highest peak, Nenang Peak, at 6870 m. The glacial and paraglacial landscapes are highly developed in the watershed, with a total of 294 glaciers (> 0.05 km² around 2005) covering a combined area of 396 km² (RGI Consortium, 2017). There are 96 glacial lakes (> 900 m² around 2015) distributed in the watershed with a total area of 3.2 km² and an average area of 0.03 km² (Zheng et al., 2021), of which the majority are moraine-dammed lakes. The watershed is part of the subhumid monsoon climate zone of the plateau with cold winters and cool summers (M. Sun et al., 2014). The average annual temperature recorded from the Lhari weather station during 1980–2019 is -0.2 °C with an average lowest temperature of -10.6 °C in January and an average highest temperature of 8.9 °C in July (Fig. 1). The average annual total precipitation is 753 mm, and about 80 % is concentrated from May to September (Fig. 1), largely controlled by the south Asian monsoon (M. Sun et al., 2014).

From the administrative location, the Zhongyu township where Jinwuco is situated is part of the southeastern Lhari County, 118 km from the county seat. It contains 14 administrative villages in total. Six of them are within the middle and upper reaches of the Nidou Zangbo basin (Fig. 1).

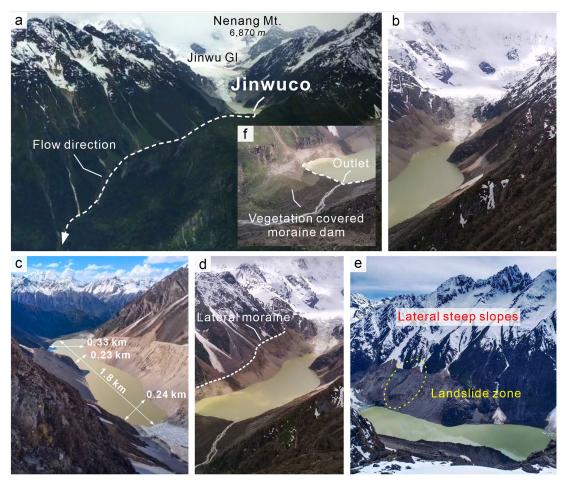
Figure 2. Overview of Jinwuco before the collapse of the dam. (a) An overall view of Jinwuco and surroundings taken from the opposite valley on 19 June 2020. (b) Crevassed hanging glacier ice terminated in Jinwuco, taken from downstream to upstream of the lake on 11 June 2020. (c) Morphological parameters of Jinwuco; photo taken from upstream to downstream of the lake on 15 June 2020. (d) Lateral moraine and steep mountain slopes from west to east (11 June 2020) and (e) from east to west (30 May 2020). (f) Vegetation-covered moraine dam and the position of the outlet (11 June 2020). Photos: Qiangba Quying (used with permission).

Jinwuco (also known as Jiwengco, 30.356° N, 93.631° E) is a proglacial moraine-dammed lake (Fig. 2) which is also the largest glacial lake within the Nidou Zangbo basin (Zheng et al., 2021). It is situated at the terminal of the Jinwu Glacier that covers an area of 7.9 km², and the lake is in contact with the steep ice tongue. The ice tongue enters the lake

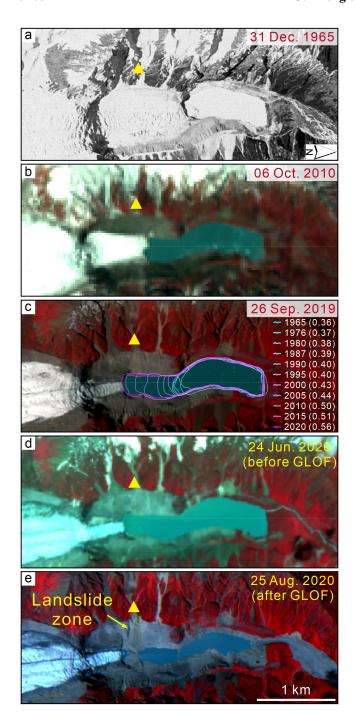
Figure 3. Satellite images documenting the evolution of Jinwuco during 1965–2020 and the location of the debris landslide. The lake area in parentheses of panel (c) is given in square kilometers. The backgrounds are from Corona KH-4A, Landsat-5 TM, Sentinel-2A, Gaofen-1, and Ziyuan-3, respectively.

Historical satellite images reveal that Jinwuco has undergone significant areal expansion since 1965 (Fig. 3). In 1965, its surface area was $0.36 \pm 0.003 \, \mathrm{km^2}$. By 10 May 2020, the lake area has increased to $0.56 \pm 0.02 \, \mathrm{km^2}$, showing an increase of approx. $56 \, \%$ relative to 1965 (Fig. 4). Overall, the surface area of Jinwuco shows a non-linear growth trend from 1965 to 2020 — with an accelerated growth rate observed from 1995. Importantly, the rear part of the lake, where the landslide deposited, is shown to have developed since 2010 (Fig. 3). After the GLOF event on 26 June 2020, the lake area is reduced by approx. $54 \, \%$ to $0.26 \pm 0.01 \, \mathrm{km^2}$ (Fig. 4).

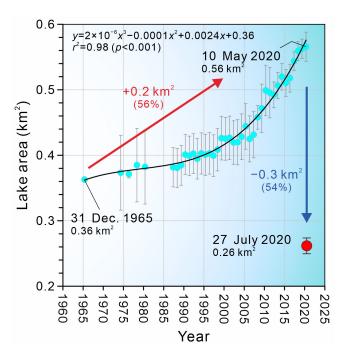
Figure 4. Inter-annual dynamics of Jinwuco during 1965–2020 (prior to the GLOF), and the abrupt decrease in lake area after the GLOF.

- 1. *Lake*. The pre-event lake area was approx. 560 000 m² (Fig. 4), with a maximum width of ca. 360 m. A lake volume of 13.9 million cubic meters is reconstructed (Sect. 4.4), corresponding to a maximum lake depth of 54 m. The pre-event lake level is set to 4444 m, whereas the post-event lake level is set to 4424 m, resulting in a drop of 20 m during the event. In the frontal portion of Jinwuco, some discrepancies exist between the post-event lake extent derived from the DEM and the satellite image (Fig. 5): this mismatch most likely indicates inaccuracies of the DEM.
- 2. *Landslide*. The Gaofen-1 imagery of 24 June reveals that the landslide had not yet happened until this point in time. Assuming that the landslide occurred before the GLOF, we constrain the timing of the landslide to the period 24–26 June 2020. A landslide release volume of

(Bolch et al., 2019) and particularly align to the period of accelerated expansion of Jinwuco (Fig. 4). While there are few studies directly linking the response of individual or even regional glacial changes to anthropogenic warming, it is considered extremely likely that anthropogenic emissions have been the primary driver of the cumulative glacier mass loss observed globally since 1850, with a central estimate of up to 100 % (Roe et al., 2021). Physically there is no obvious argument to suggest glaciers in this region of Tibet have responded anomalously from what has been established globally. If we therefore consider that anthropogenic warming has at least played a major (if not dominant) role in the retreat of Jinwu Glacier and associated lake growth, the discussion turns to how this retreat could have increased the likelihood and/or magnitude of the 26 June GLOF event. It is well established that paraglacial landscapes are characterized by anomalously high rates of erosion and mass movements compared to other environments, with debris flows, slides, and avalanches being the primary mode of failure (McColl, 2012; Knight and Harrison, 2014). The reworking and modification of paraglacial landscapes occurs rapidly following glacial retreat, with stabilization of proximal slopes occurring within a few decades to centuries (Ballantyne, 2002). Over this time, paraglacial slopes remain particularly susceptible to heavy rainfall or melt processes (Blair, 1994; Evans and Clague, 1994; Chiarle et al., 2007), and when mass movements of rock or debris enter adjacent lakes, GLOFs

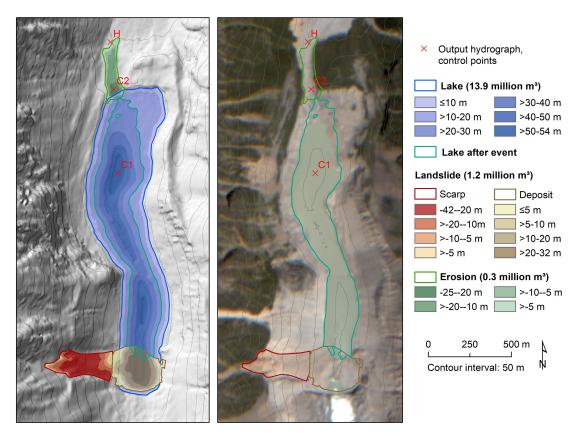
Figure 5. Reconstruction of the lake depth, landslide, and breach of the moraine dam. The base map is a shaded relief map (left) based on the DEM generated from Ziyuan-3 stereoscopic pairs and the Ziyuan-3 satellite scene (right) acquired on 25 August 2020.

The reconstruction of the main features allows for drawing some conclusions about the mechanisms involved in the GLOF process chain and for estimating the mobilized volumes (Figs. 5 and 6).

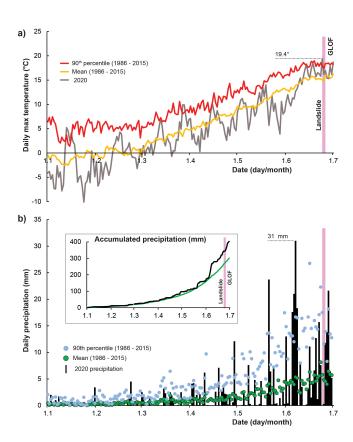
Figure 7. Meteorological conditions from January–June 2020, measured at the Lhari weather station, compared to the longer-term climatology (1986–2015).

We now elaborate on the possible triggers of the landslide. The meteorological conditions in June 2020 (Fig. 7) were characterized by extremely high precipitation in the period from 5–8 June. Further rainfall and snowmelt under unusually warm conditions after 8 June are factors which most likely caused a gradual destabilization of the moraine. The

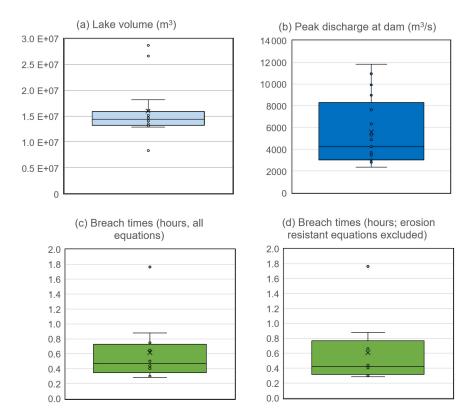
Figure 8. Lake, dam breach, and flood parameters, derived from sets of published empirical relationships. (a) Volume of Jinwuco. (b) Peak discharge at the dam. (c) Breach time, considering all available equations. (d) Breach time, considering only those equations derived for easily erodible dams (an assumption we consider likely to hold for the dam of Jinwuco).

The patterns yielded with the simulation of Scenario B (Fig. 9c and d) are similar in general, with the exception of the initial impact wave that is only observed in Scenario A. However, onset of erosion takes more time, so that the breach and associated emptying of the lake are delayed. The tipping point where slight channel erosion turns into a rapid dam breach occurs at approx. 35-39 min after the start of the simulation, depending on the definition. The base level of the erodible material is reached at t = 62 min (23–27 min or 0.38-0.45 h after the tipping point – in the lower part of the range indicated in Fig. 8d). The peak discharge of $4600 \text{ m}^3/\text{s}$

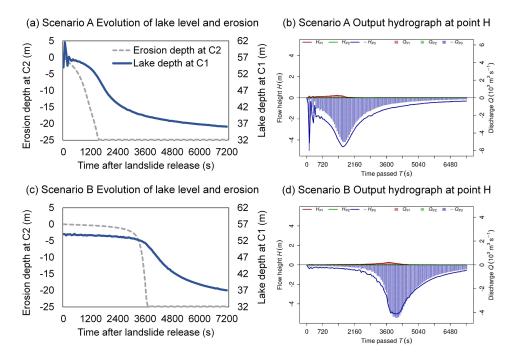
Figure 9. Dam breach as simulated with r.avaflow. (a) Scenario A, evolution of lake level and the erosion channel. (b) Scenario A, output hydrograph. (c) Scenario B, evolution of lake level and the erosion channel. (d) Scenario B, output hydrograph. Locations of the points C1, C2, and H are indicated in Figs. 5 and 11. In the output hydrographs, H means flow height, and Q means discharge. The subscript P1 refers to phase 1 (rock), P2 to phase 2 (not existent in this case), and P3 to phase 3 (water). Fluid discharge and flow height are plotted in the negative direction for better readability.

A detailed look at the dam breach (Fig. 9) reveals that the simulation results for both scenarios A and B are in good correspondence with the ranges of peak discharge and breach depth derived through the empirical relationships described in Sect. 4.4 and illustrated in Fig. 8. For Scenario A, at the point C2 (Figs. 5 or 10), depth erosion is completed at $t = 26 \,\mathrm{min}$ after landslide release, i.e., 24–25 min (0.41 h) after the impact wave had reached the outlet of the lake, initiating retrogressive erosion. This time span is well within, although in the lower part of, the range revealed in Fig. 8d. After the breach has developed to its full depth, lake drainage continues and asymptotically approaches the level of the eroded gully (Fig. 9a). The peak discharge associated with the landslide-induced impact wave reaches 17 900 m³/s after 100 s (computed at a higher temporal resolution and therefore not visible in Fig. 9b). Afterwards, discharge decreases and then increases again due to retrogressive erosion of the moraine dam. The simulated peak discharge during the retrogressive erosion stage reaches $5200 \,\mathrm{m}^3/\mathrm{s}$ at $t = 28 \,\mathrm{min}$, being well within the range indicated in Fig. 8b. With dropping lake level, the simulated discharge slowly decreases to a small residual value after 2 h (Fig. 9b). At all stages, the simulated flow is dominated by water, with a peak of approx. 220 m³/s of solid discharge at t = 23 min, when retrogressive erosion is the most intense.

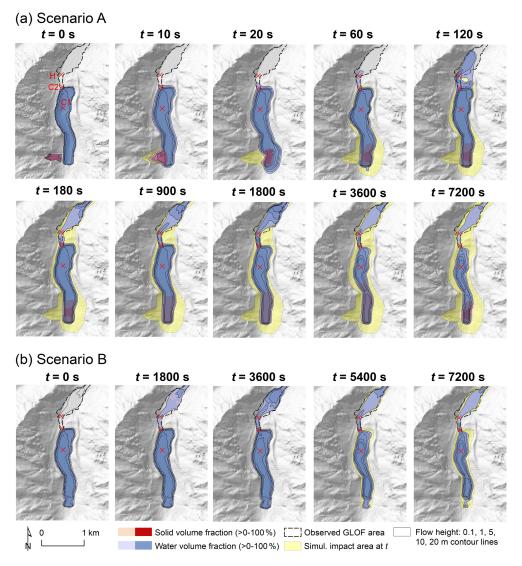
Figure 10. Evolution of flow height and GLOF impact area as well as solid and water volume fractions during the first 2 h of the event, as simulated with r.avaflow for (a) Scenario A and (b) Scenario B. Only the section until the floodplain immediately downstream from the moraine dam is considered in these simulations. The base map is a shaded relief map based on the DEM generated from Ziyuan-3 stereoscopic pairs and the simulation results.

timing and mechanisms of high-mountain process chains such as GLOFs. The understanding of events in earlier history sometimes suffers from the impossibility of determining the cause of a GLOF due to lacking data: in the 1941 event at Lake Palcacocha in the Peruvian Andes (Mergili et al., 2020), there is still speculation about triggering of the catastrophic moraine dam breach by calving or an ice avalanche, however poorly supported by evidence. In the case of the Jinwuco event, in contrast, there is clear evidence that a landslide has entered the lake not more than 2 d before the GLOF (Fig. 3), even though the quantification of landslide volume is to be interpreted as a rough estimate rather than exact value, given the hard-to-quantify uncertainties in the available pre- and post-event DEMs. We assume a direct temporal coincidence between the two processes, with the landslide having triggered the GLOF, as the most likely set of scenarios. However, there is strong evidence that there was no massive, extremely rapid landslide impact into the lake: comparison of pre-event and post-event satellite imagery reveals no overtopping of the dam and not even the run-up of lake water on the inner side of the moraine dam (Figs. 3 and 5). Both the simulation (Scenario A; Fig. 10a) and observations of other GLOFs (e.g., Schneider et al., 2014) would reveal such a behavior. Therefore, we consider a rather slow and/or progressive movement of the landslide into the lake much more likely, represented by Scenario B (Fig. 10b).

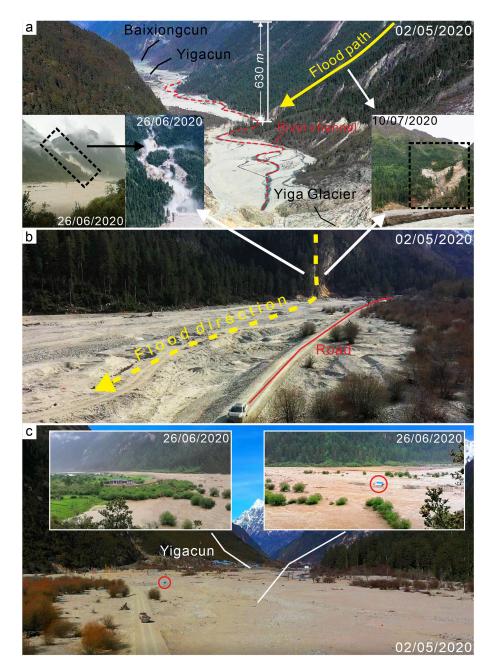
Figure 11. The situations in the valley and river channel below Jinwuco before, during, and after the GLOF. (a) Photo taken from Yiga Glacier looking to Yigacun. Insets showing the situations in the valley during and after the GLOF (photos: Qiangba Quying and Yixi Quzhen). (b) The river channel and road before the GLOF taken from Yigacun looking upstream. The yellow dashed line is the flood flow direction. (c) A view taken from upstream looking to Yigacun. Insets showing the situations in the river channel during the GLOF (photos: Qiangba Quying). Aerial photos from 2 May 2020 were taken by Kejun Liang.

Figure 11 shows the valley and river channel below Jinwuco before, during, and after the GLOF. It is evident from the comparison of the photographs that the floodwaters almost inundated the wide river valley downstream and reached the location of Yigacun, which is located in a relatively high position. The large elevation difference between the surface of Jinwuco and the downstream river channel (approx. 630 m) provides significant potential energy, setting the stage for enhanced erosion and greater damage. Further, the flood caused severe erosion of the lower valley and alteration of the river channel below through the formation of alluvial fans. Figure 12 gives a picture of the situation during the flood further downstream at the location of Zhongyucun. The aerial photograph shows that the massive impact of the flood washed away roads and bridges and put some buildings along the river at risk. The Zhongyu township has experienced rapid development and expansion of infrastructure over the past 15 years (some examples are shown in Fig. 13). Such development has increased the level of exposure to potential GLOFs, as shown in Fig. 12c: these buildings were constructed recently in areas located directly on the riverbanks and exposed to flooding.

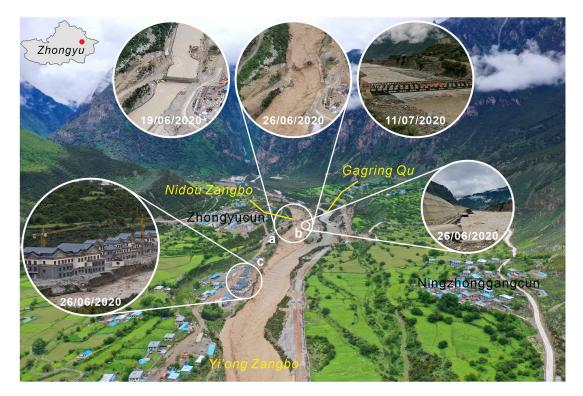
Figure 12. Examples of GLOF damage to downstream infrastructure and buildings at the confluence of Nidou Zangbo and Gagring Qu. Background aerial photo by Heng Li taken on 26 June 2020. (a) Comparison of the bridge connecting Zhongyucun and Ningzhonggangcun before, during (photos: Heng Li), and after the GLOF (rebuilt, photo: Kejun Ma). (b) Destroyed roads (photo: Heng Li). (c) Affected buildings at risk (photo: Heng Li).

caused severe destruction to villages and infrastructure to various degrees on both sides of the downstream river. The destruction consists mainly of damage to buildings, roads, bridges, or farmland, just to name a few (detailed statistics are provided in Table 3). Fortunately, this event did not lead to any fatalities or injuries largely because it took place during the daytime, and the villagers collecting medicinal herbs upstream observed the flood and promptly informed the downstream villages to evacuate. The affected area includes almost all the villages on both sides of the river, especially Baixiongcun and Zibucun. These are also the most affected by the 2013 Ranzeriaco GLOF (Fig. 1; Liu, 2014). The power of the flood is noticeably weakened after its confluence with the Gagring Qu in the Zhongyucun and hence does not result in much damage to areas further downstream. This flood damaged a major proportion of 43.9 km of roads between Yigacun and Zhongyu township (Fig. 1; Fig. 11), as well as the only steel bridge to the township office (Fig. 12a), which caused certain difficulties for timely emergency rescue operations.
